UNITED UTILITIES SUSTAINABLE CATCHMENT MANAGEMENT PROGRAMME

VOLUME 1 EXECUTIVE REPORT

October 2011

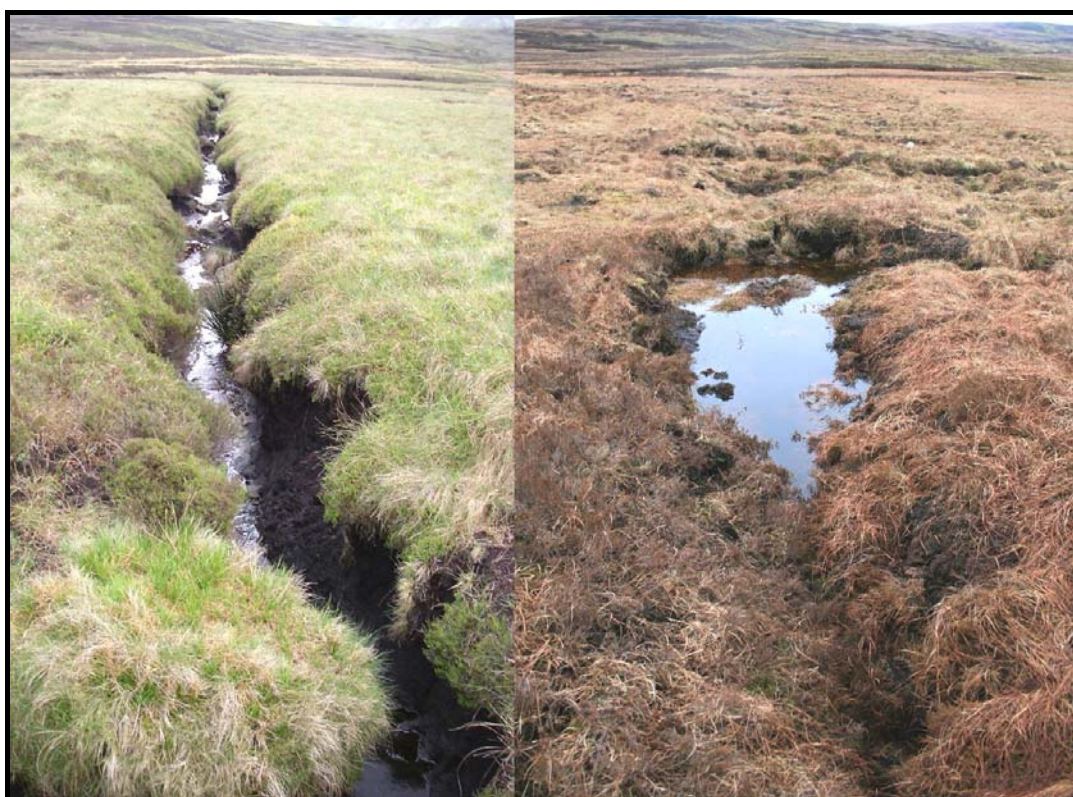
Photograph 1 Brennand Brown Syke Sub-Catchment 2007 Before (left) and 2009 After (right) Major Grip Blocking Work was Completed

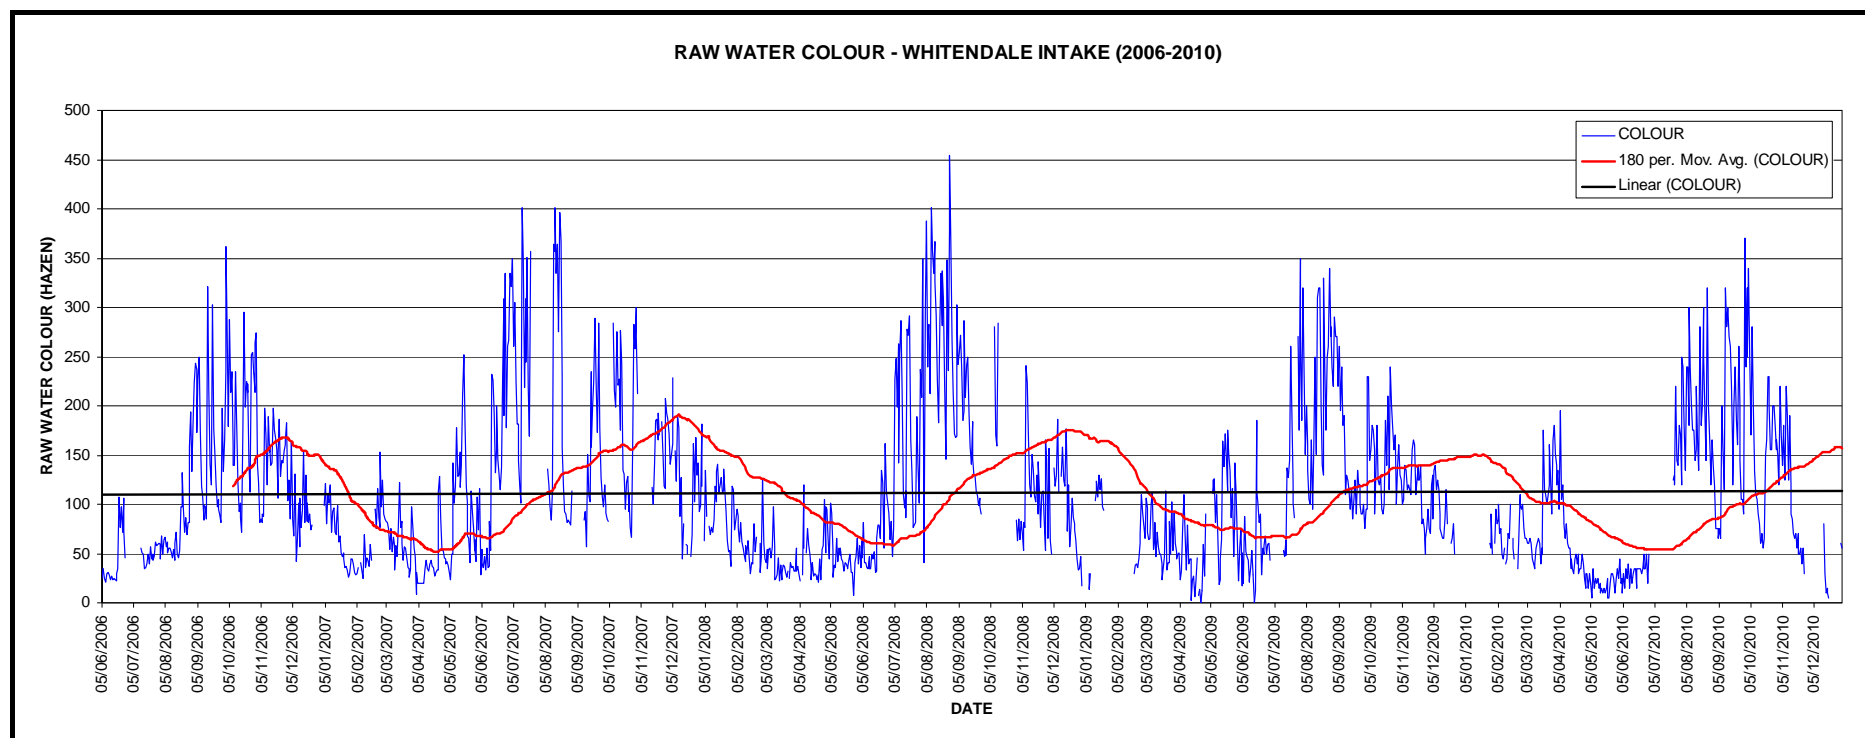
Figure 9 Raw Water Colour – Whitendale Intake

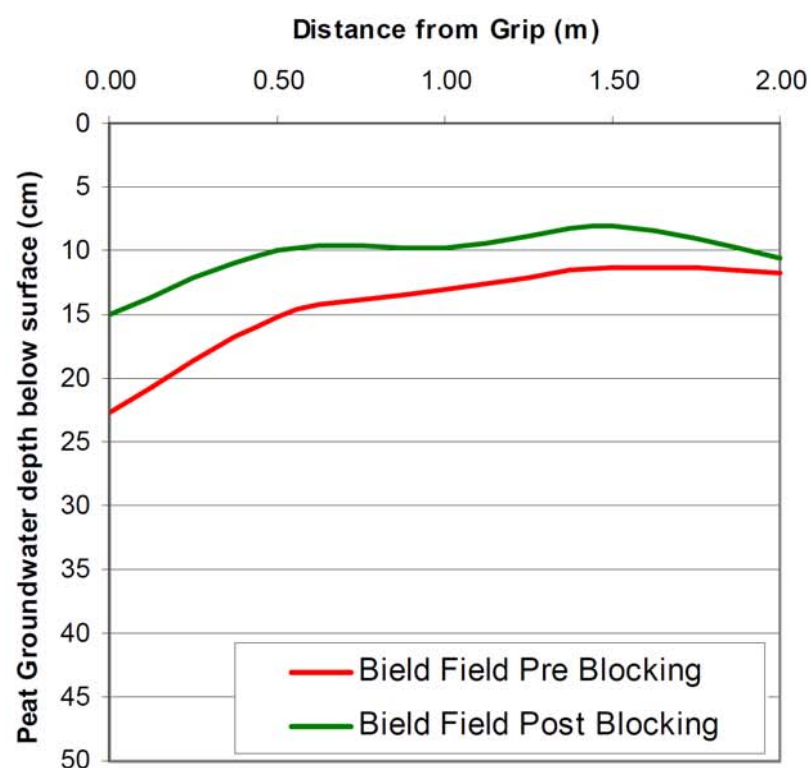
Figure 11 Water Table Levels in the Peat Pre and Post Grip Blocking Brennand. Figure 11a Bield Field (western side of catchment), Figure 11b Brown Syke (eastern side of catchment, with greater level of grip erosion prior to damming)

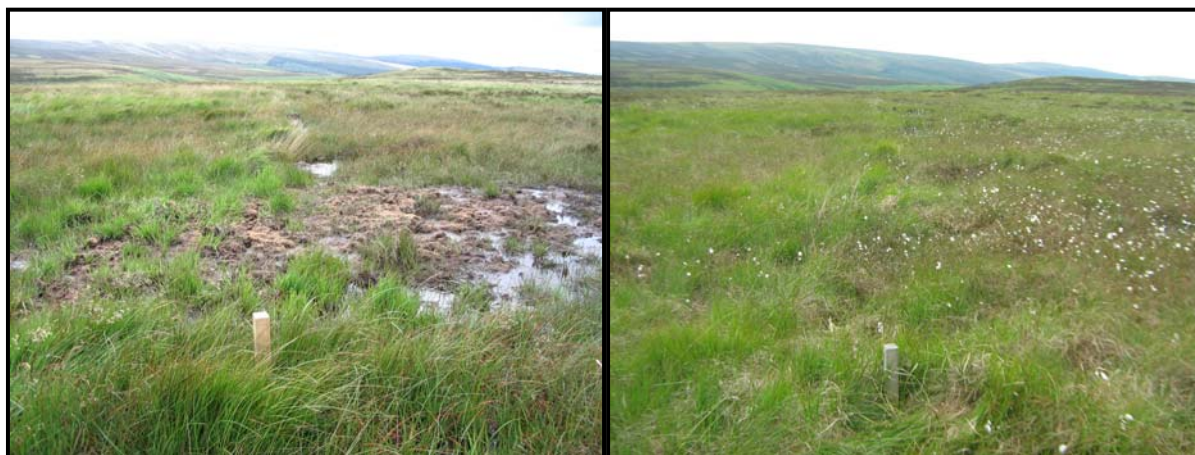
Photographs 2 and 3 Goyt Plot (BB5) With Reduced Summer Grazing/Off-wintering, Removal of Heather Burning and Block of Grips with Peat and Plastic Dams, 2006 (left) and 2010 (right), Illustrating Significant Re-vegetation of Damaged Area

The wettest site, BB5 (plastic and peat dams), showed increases in *Sphagnum* ($p < 0.001$) related to increases in *Sphagnum fallax*. This site had a greater initial cover of *Sphagnum* and responded more rapidly to the rewetting (Figure 16 page 26). Other gripped/blocked plots show a trend towards increasing *Sphagnum*, again largely related to increases in *Sphagnum fallax*, but several other *Sphagnum* species were also recorded for the site. No *Sphagnum* was recorded on the drier plot (BB4). The unblocked gripped site (BB3) showed a significant decline in hare's-tail cottongrass (*Eriophorum vaginatum*; $p < 0.001$)

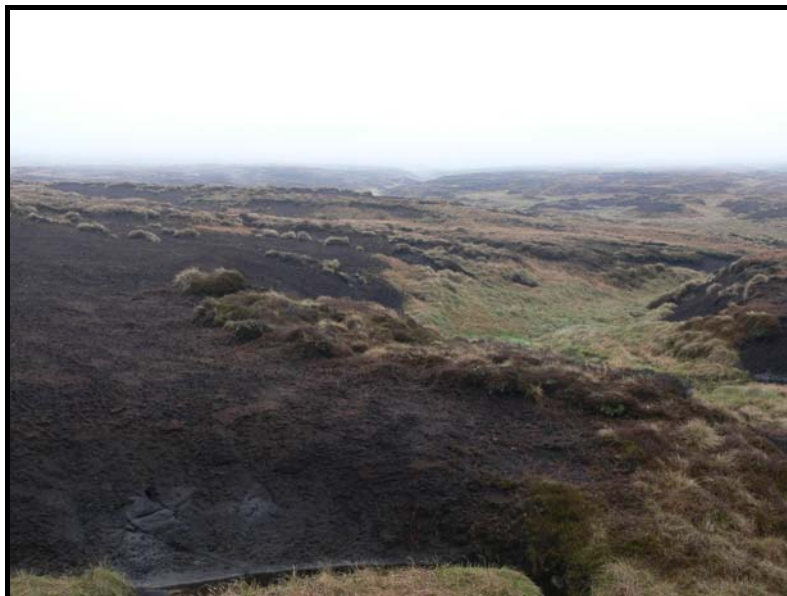
Photograph 4 *Degraded Nature of part of Ashway Gap Prior to Restoration*

The vegetation of the area is poor in species and dominated by hare's-tail and common cottongrasses (*Eriophorum vaginatum* and *E. angustifolium*) with crowberry (*Empetrum nigrum*) and bilberry (*Vaccinium myrtillus*) on the drier peat. Heather (*Calluna vulgaris*) is only locally abundant. *Sphagnum* and other mosses are scarce but currently increasing as a response to reductions in sulphur dioxide.

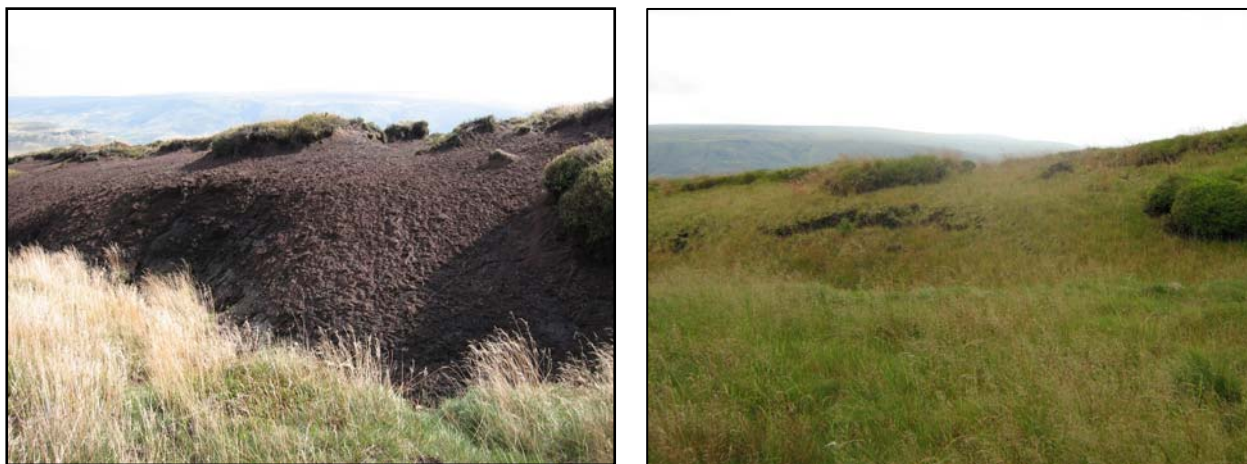
Photographs 5 and 6 Lime, Seed, Fertiliser Plot Treated With Brash Plus Geojute (BB6b) on a Steep Slope, September 2007 (left) and July 2010 (right)

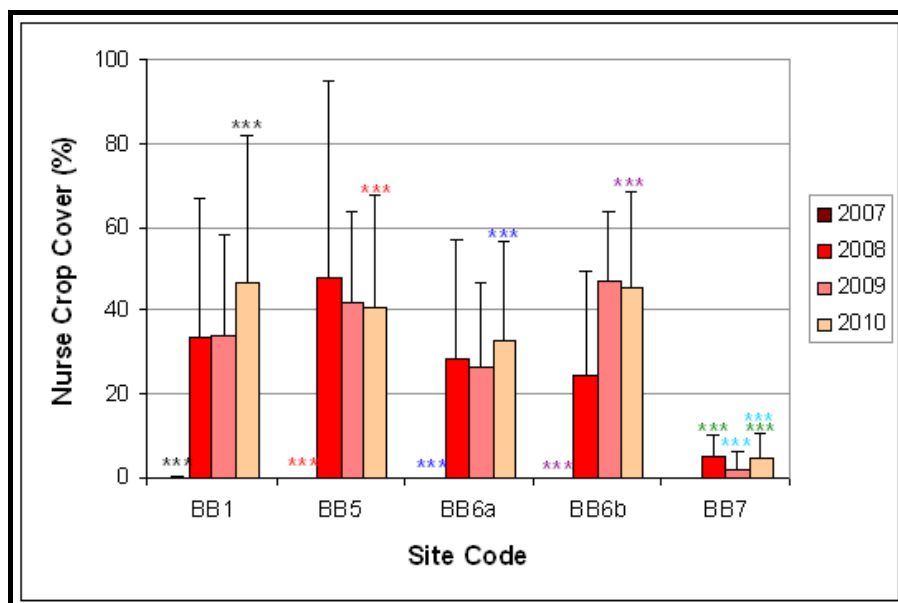
Figure 21 Nurse Crop Cover (mean and standard deviation) across North Longdendale Before (2007) and After (2008 onwards) Restoration. BB1 and BB5, gently sloping, treated with lime, fertiliser and grass seed, BB6a and BB6b on steeper slopes treated with lime, fertiliser, grass seed and heather brash, BB6b with geojute as well. BB7 reference site untreated. NB – No Data Available for BB7 in 2007

All treated plots had significantly greater cover of nurse grass species than the untreated plot ($p < 0.001$) and differences between years is also significant ($p < 0.001$) and the increase from 2007 (the baseline year) to 2010 is significant for all treated plots while the decrease on the untreated plot (BB7) is largely related to a reduction in the existing cover of wavy hair-grass. The addition of brash and geojute (BB6b) appeared to aid the establishment of vegetation more effectively than brash alone (BB6a). For areas where some vegetation is already present and on more gentle slopes, the application of lime, nurse crop and fertiliser (LSF treatment) has encouraged a good rate of vegetation establishment (BB1 and BB5).

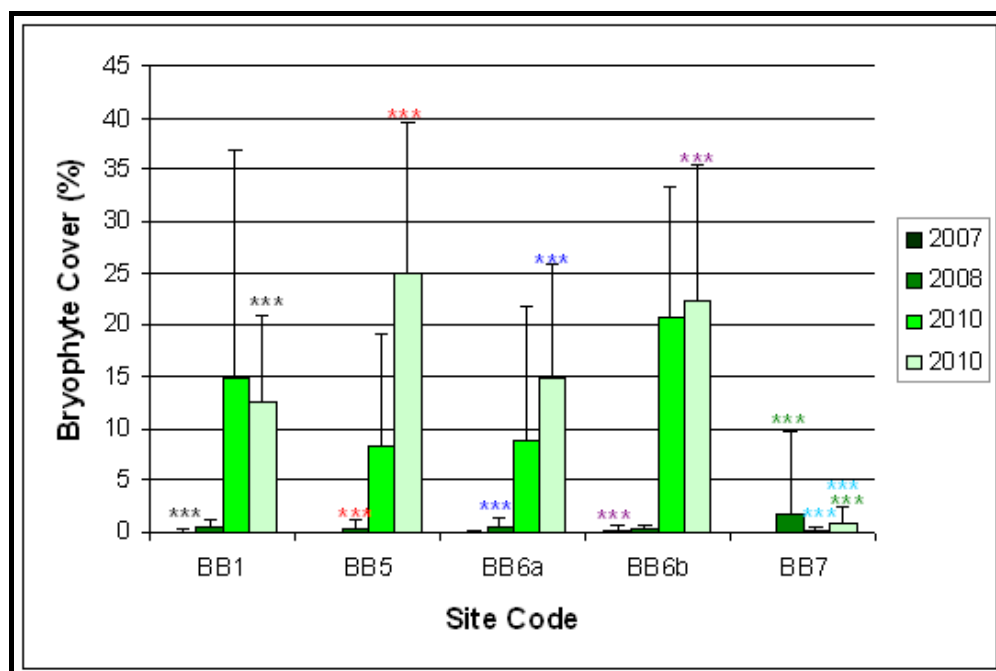
Figure 23 Moss Cover (mean and standard deviation) Across North Longdendale Before (2007) and After (2008 onwards) Restoration. BB1 and BB5, gently sloping, treated with lime, fertiliser and grass seed, BB6a and BB6b on steeper slopes treated with lime, fertiliser, grass seed and heather brash, BB6b with geojute as well. BB7 reference site untreated. NB – No Data Available for BB7 in 2007

Mosses (Figure 23 page 38) showed similar trends, with all treated plots showing significant increases in cover compared with the untreated plot ($p < 0.001$). This is largely attributable to an increase in *Campylopus* species, but also relates to some increases in *Hypnum jutlandicum*, particularly on the plots treated with brash (BB6a and BB6b), possibly a result of propagules being introduced with the brash.

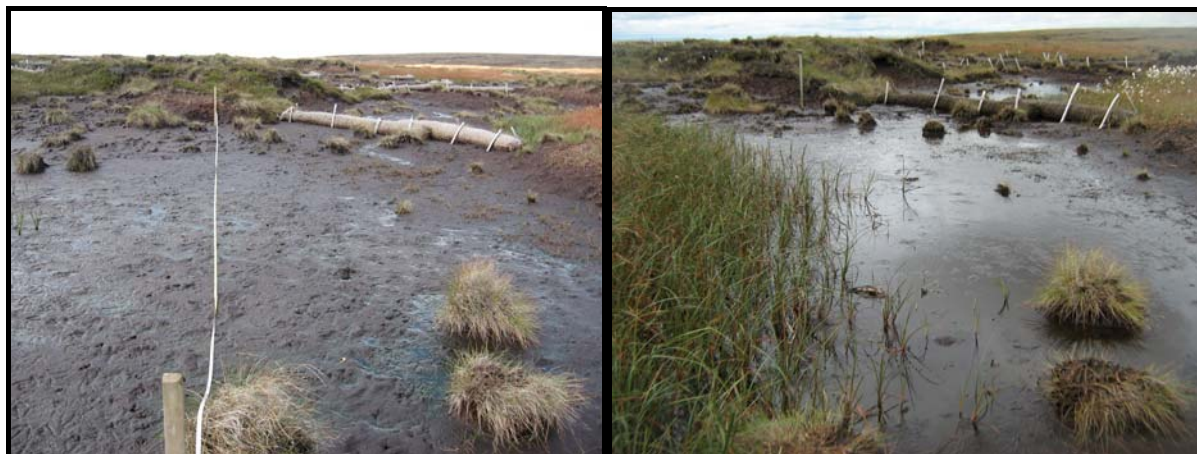
Photographs 7 and 8 Bare Peat Pan With Grazing Removed and Coir Roll Installed (BB2b), September 2007 (left) and July 2010 (right), Illustrating the Expansion of Common Cottongrass During the Monitoring Period

Changes in the vegetation on the two plots indicate that the removal of grazing appears to be having the greatest effect on the plant species, with both plots showing trends towards increases in dwarf shrub cover and frequency, common cottongrass cover (Figure 25 page below) and moss cover and frequency over time. However, the increases are very small as would be expected on such a severely degraded peatland. As yet there are no statistically significant differences over time for either plot, although photographic evidence shows some visible changes (Photographs 7 and 8 page 41).

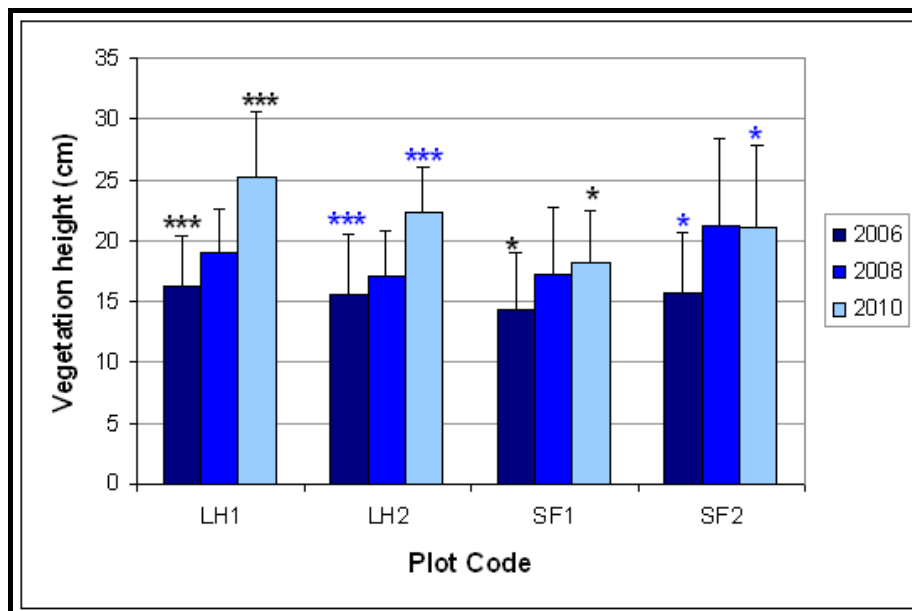
Figure 27 Vegetation Height (mean and standard deviation) for Lamb Hill (LH) and Sykes Farm (SF). LH1: reduced grazing all year, LH2: reduced grazing winter only, SF1: reduced grazing, SF2: reduced grazing

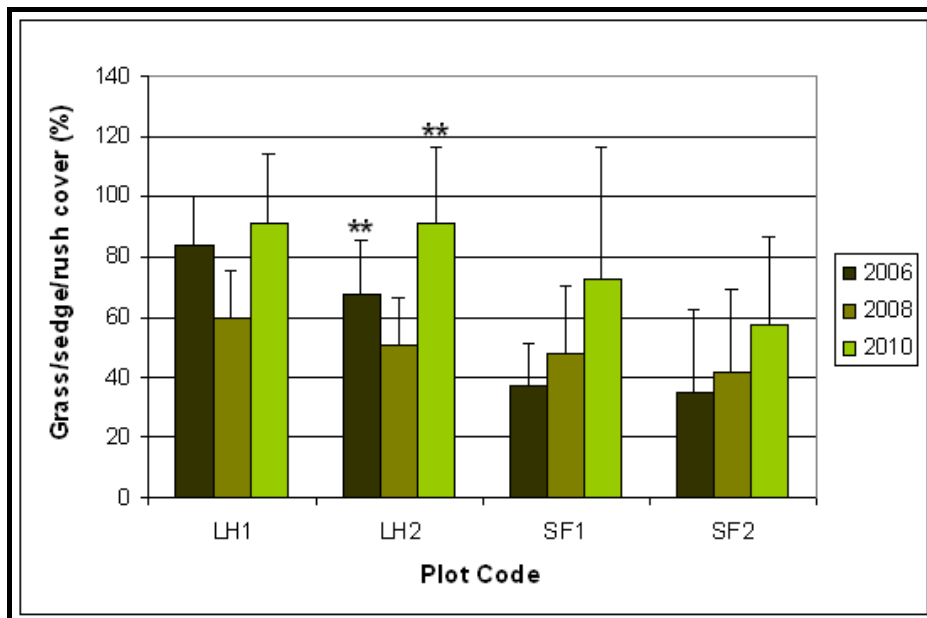
Figure 28 Total Grass/Sedge/Rush Cover (mean and standard deviation) for Lamb Hill (LH) and Sykes Farm (SF). (LH1, reduced grazing all year, LH2; reduced grazing winter only, SF1: reduced grazing, SF2: reduced grazing)

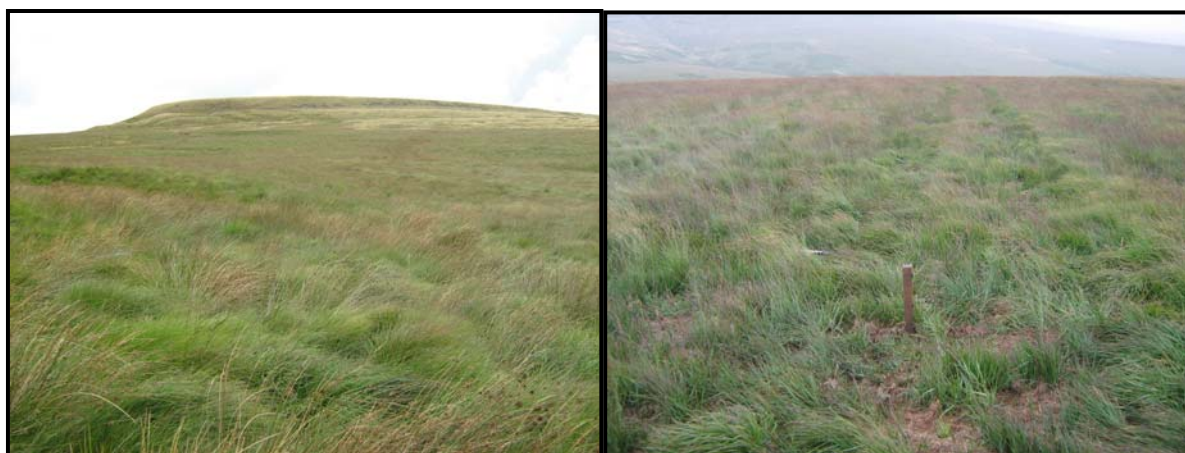
Photographs 9 and 10 Pikenaze Estate Illustrating Untreated (left) and Treated (right) Plots in 2007 After First Purple Moor-Grass Reversion Treatment, Showing Significant Reduction of Dominance of This Species Where Treated

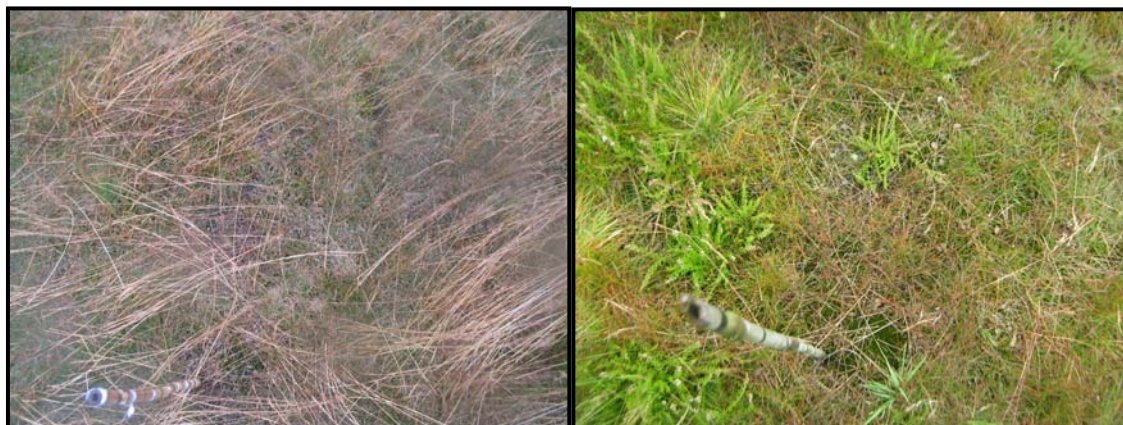
Photographs 11 and 12 Ashway Gap Dry Heath Site Illustrating Before 2006 (left) and After 2010 (right) Application of Heather Seed, Showing Establishment of Young Heather Plants

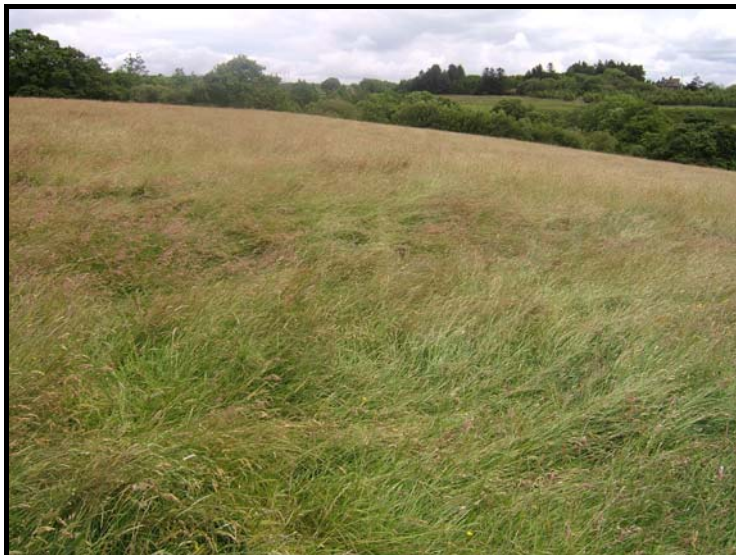
Photograph 16 Phynis Meadow on 28th June 2007, Showing Dominance of Yorkshire Fog Grass and Low Abundance of Wildflowers

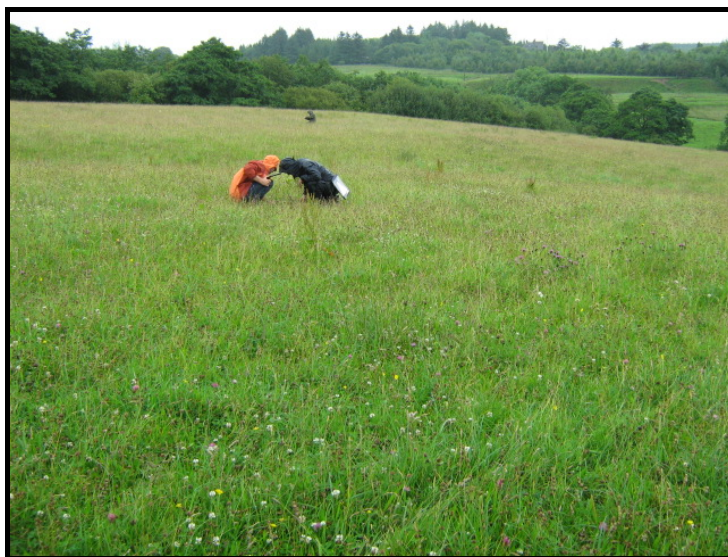
Photograph 17 Phynis Meadow on 20th July 2010, Showing a Shorter, More Wildflower-Rich Sward after Three Years of Traditional Hay Meadow Management
