UNITED UTILITIES SUSTAINABLE CATCHMENT MANAGEMENT PROGRAMME

VOLUME 3 THE RESTORATION OF HIGHLY DEGRADED BLANKET BOG

October 2011

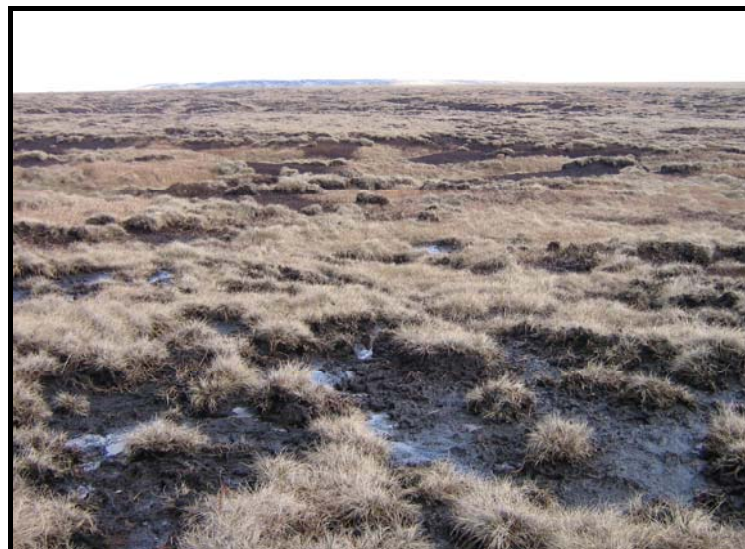
Photograph 1 Degraded Nature of the Ashway Gap Monitoring Site

Typically, the area sits on the Millstone Grit Series with exposures of shales and gritstone. A ubiquitous, (but variable) depth of head deposits forms the base for an overlying deep blanket bog peat. These peats are typical of the wider North Longdendale areas and in many places are significantly eroded with extensive tracts of bare peat and deeply incised gullies into the peat mass.

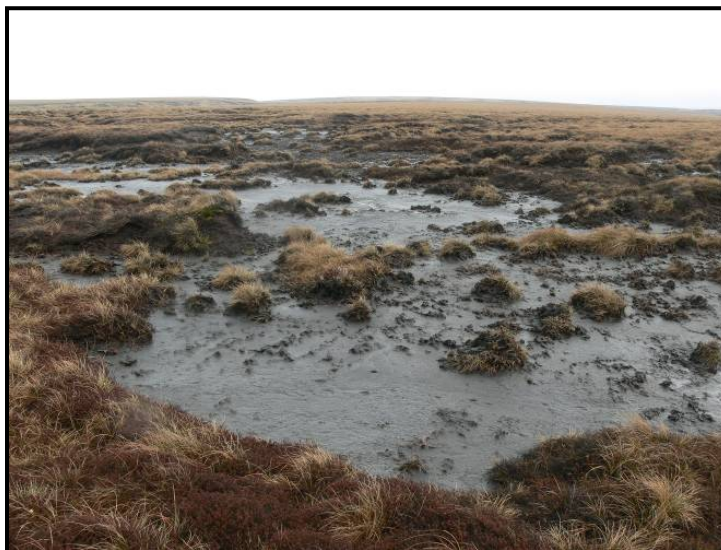
Photograph 5 *Peat Pans on Flat Areas at Top of Catchment on Ashway Gap*

The dramatic and degraded landscape generates a highly coloured and sediment-loaded runoff. A critical mechanism in the degradation process is the initial loss of vegetation cover which leads to gullying of the bare peat surface. Once initiated, this starts to erode the blanket peat leading to a change in topography. These processes produce the degraded landscape types, first classified by Bower (1960).

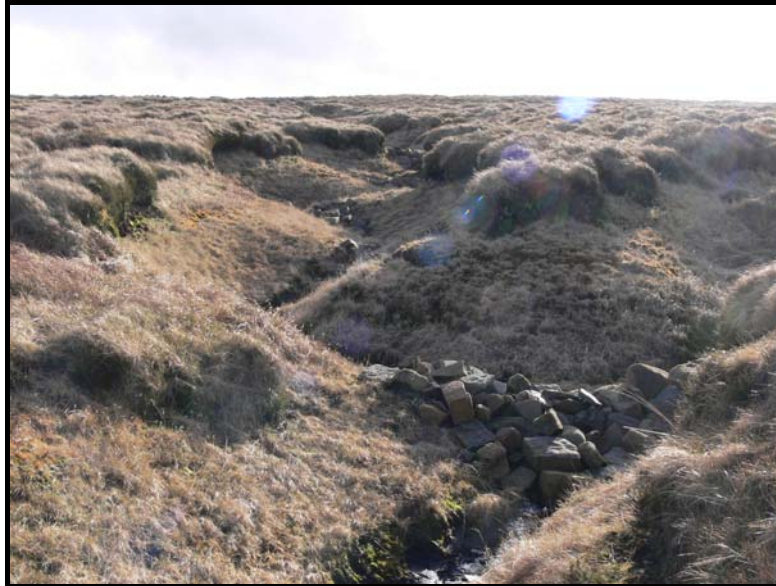
Photograph 7 *Recent Gully Blocking Work with Local Stone Blindstones Moss, Ashway Gap*

Once the peat stabilisation works related to the re-vegetation were completed, some gully blocking work was undertaken at strategic locations across the restoration sites on Ashway Gap (see Photograph 7 below). These gully blocks consist of natural gritstone blocks dumped into the base of gully systems by helicopter, before being re-worked by hand to become more stable and less susceptible to damage; either from high-intensity, ephemeral stormflow, or due to a build up of pressure caused by ponded standing water accumulating immediately upstream.

The focus at Ashway Gap has primarily been on reducing particulate organic carbon delivery to streamflow by re-vegetation of the degraded blanket peat body. To date, the gully blocks appear to have been largely effective in holding back both particulate sediment (particulate organic carbon, POC and some mineral sediment) transported in stormflow runoff events and re-deposited when flow recedes, as well as slightly retarding the flow of water through the system in major stormflow events. Small temporary pools behind some dams are evident, which will assist in rewetting adjacent peat. However, no quantitative analysis has been undertaken to date on assessing the effectiveness of these features and so time will tell whether they prove to be entirely effective. However, early results look promising.

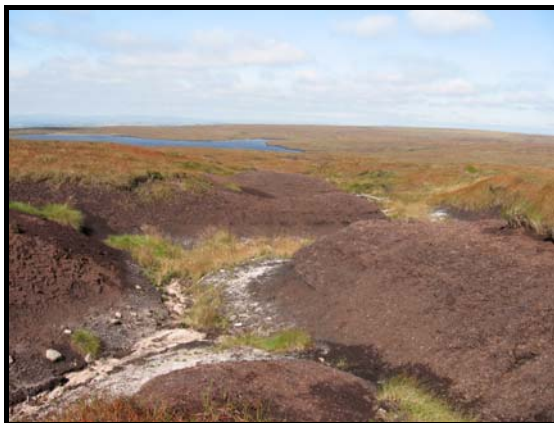
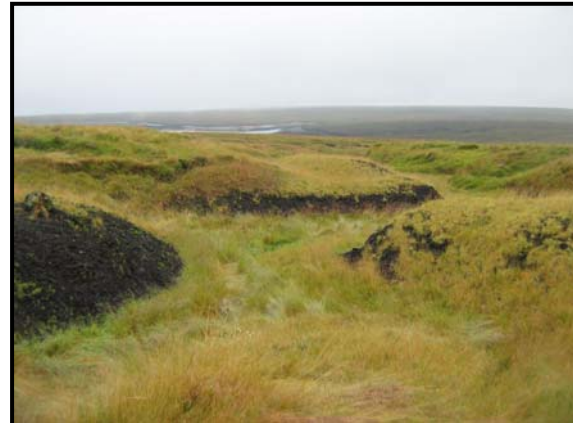
Photographs 8 and 9 Lime, Nurse Crop Seed and Fertiliser Treated Plot (BB1), September 2007 prior to treatment (left) and July 2010 After Treatment (right), illustrating the successful establishment of vegetation using the nurse grasses

Photographs 8 and 9 (page 22) show the change in the plot treated with lime, nurse grass seed and fertiliser both before (2007) and after (2010) restoration treatment has been applied. The majority of the increase in vegetation cover was related to the establishment of the nurse crop species (Figure 9 page 23), in particular blue fescue (*Festuca longifolia*), Highland bent (*Agrostis castellana*) and wavy hair-grass (*Deschampsia flexuosa*). A fourth nurse crop species, perennial rye-grass (*Lolium perenne*), established in the first year after sowing but declined rapidly in the second year. By 2010, the overall cover of the main nurse crop species had stabilised after a rapid period of expansion up to 2009, but wavy hair-grass has maintained its cover or continued to increase (it is native to the site).

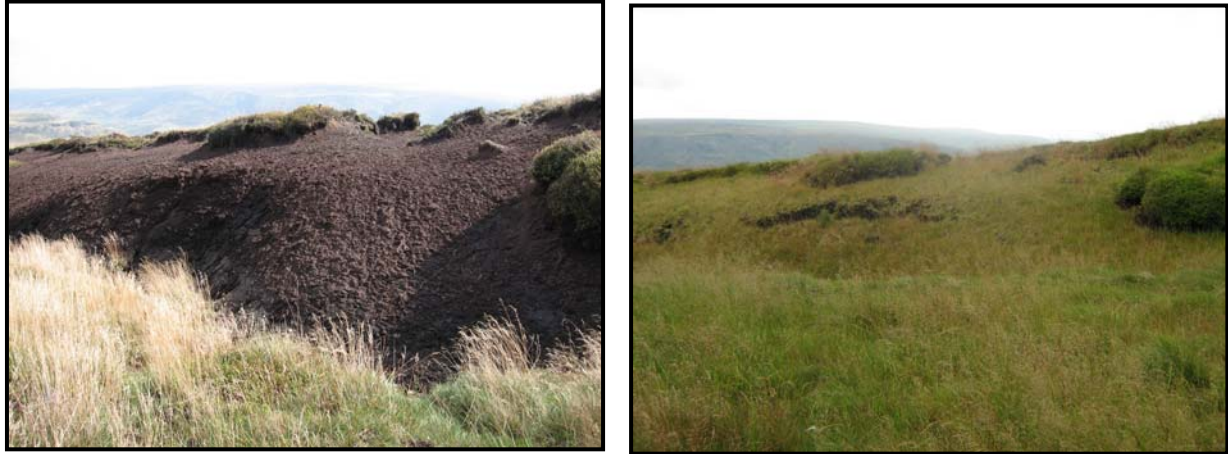
Photographs 10 and 11 Lime, Nurse Grass Seed, Fertiliser Plot Treated with Brash Plus Geojute (BB6b) on a Steep Slope, September 2007 (left) and July 2010 (right)

The addition of brash and geojute (BB6b – Photographs 10 and 11 page 24) appeared to aid the establishment of vegetation more effectively than brash alone (BB6a), however, comparisons need to be treated with care since the geojute and brash plots are on very steep gully slopes where restoration is most difficult. For areas where some vegetation is already present (BB1), and on more gentle slopes, the application of lime, nurse crop and fertiliser (LSF treatment) has encouraged a good rate of vegetation establishment (BB1 and BB5).

Table 4 (page 26) summarises the achievements of the restoration programme against the key targets set by the SSSI Site Objective Statements which themselves link to CSM targets for the SSSI. Photographs illustrating the change over time for the steeper gullies treated with lime, nurse crop seed, fertiliser, heather brash and geojute are presented in Photographs 10 and 11 (page 24).

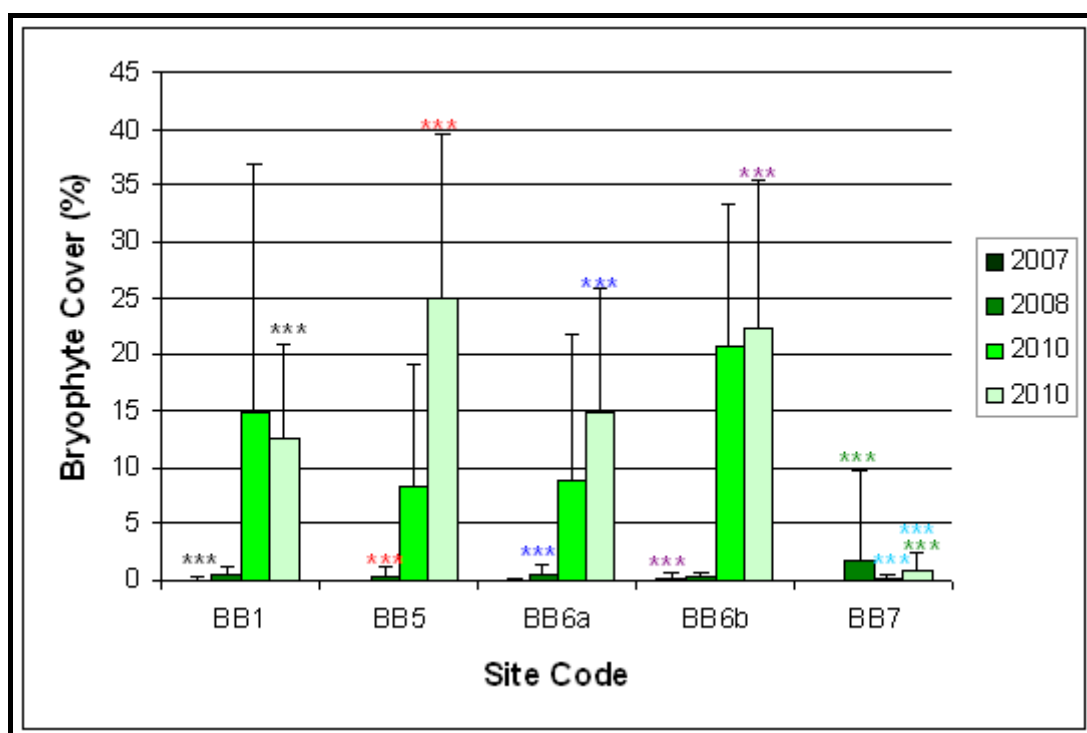
Figure 11 Moss Cover (mean and standard deviation) Across North Longdendale Before (2007) and After (2008 onwards) Restoration. BB1 and BB5, gently sloping, treated with lime, fertiliser and grass seed, BB6a and BB6b on steeper slopes treated with lime, fertiliser grass seed and heather brash, BB6b with geojute as well. BB7 reference site untreated

The results for bryophytes show similar trends (Figure 11 below), with all treated plots showing significant increases in cover compared with the untreated plot ($H = 50.1$, d.f. = 4, $p < 0.001$) and all years except 2009 and 2010, being significantly different from one another ($H = 315.3$, d.f. = 3, $p < 0.001$). This is largely attributable to an increase in *Campylopus* species, but also relates to some increases in *Hypnum jutlandicum*, the latter species being particularly abundant on the plots treated with brash (BB6a and BB6b), possibly a result of propagules of this species being introduced with the brash material. Several *Campylopus* species readily colonise bare peat once it has stabilised.

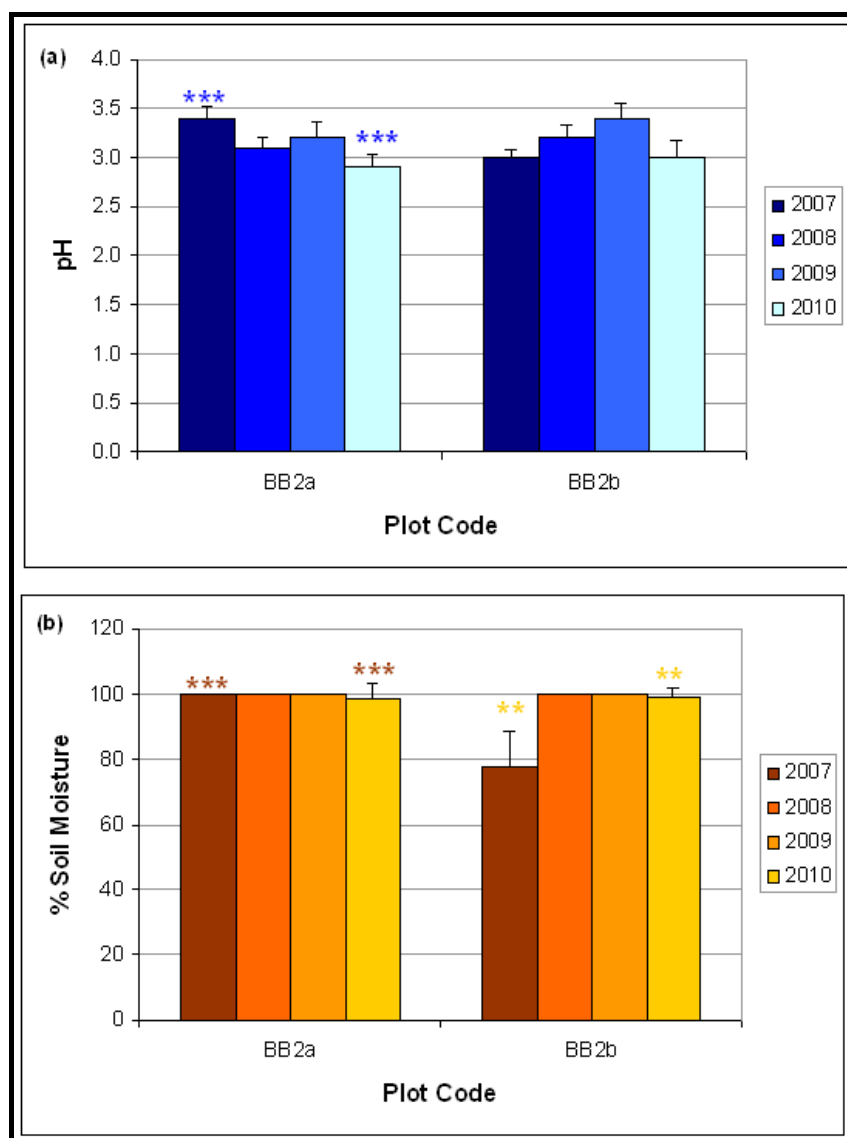
Figure 12 Peat Soil (a) pH and (b) Soil Moisture (Mean and Standard Deviation) Measurements at Ashway Gap Bare Peat Pans for Baseline¹⁰ Year (2007) and following Restoration Measures (2008 onwards). Plot BB2a is Ungrazed and Plot BB2b is Ungrazed with Coir Rolls Installed

the pH being recorded at between 3.0 and 3.5 on average. In terms of peat soil moisture (Figure 12b below) there was also a significant difference from 2007 to 2010 overall ($H = 28.2$, d.f. 3, $p < 0.001$) with the coir roll treated plot (BB2b) showing a significant increase in soil moisture over time ($p < 0.01$) suggesting that overall the coir rolls appeared to be enabling water to be held on these areas for longer. On the untreated plot (BB2a) there was a small but statistically significant reduction in soil moisture measurement in 2010 compared to 2007, ($p < 0.001$) however this is unlikely to be ecologically meaningful.

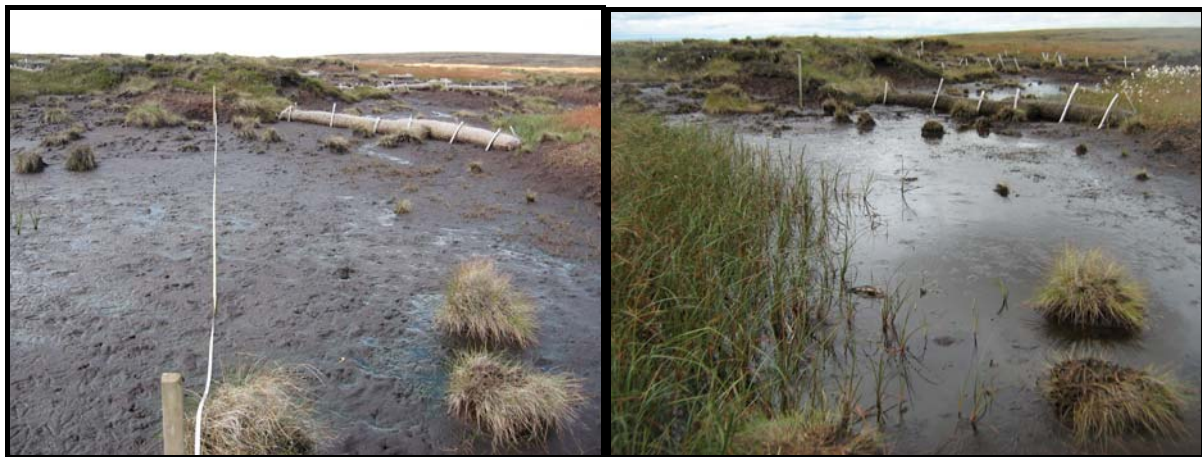
Photographs 12 and 13 Bare Peat Pan With Grazing Removed and Coir Roll Installed (BB2b), September 2007 (left) and July 2010 (right), Illustrating the Expansion of Common Cottongrass During the Monitoring Period

Changes in the vegetation on the two plots indicate that the removal of grazing appears to be having the greatest effect on the plant species, with both plots showing trends towards increases in dwarf shrub cover and frequency (Figure 14 page 29), common cottongrass cover (Figure 15 page 29) and moss cover and frequency (Figure 16 page 30) over time. However, the increases measured within the monitoring quadrats to date are very small and would be expected on such a severely degraded peatland. As yet there are no statistically significant differences over time for either plot. In some areas the changes in vegetation are identifiable through the fixed point photographic monitoring (Photographs 12 and 13 page 30).

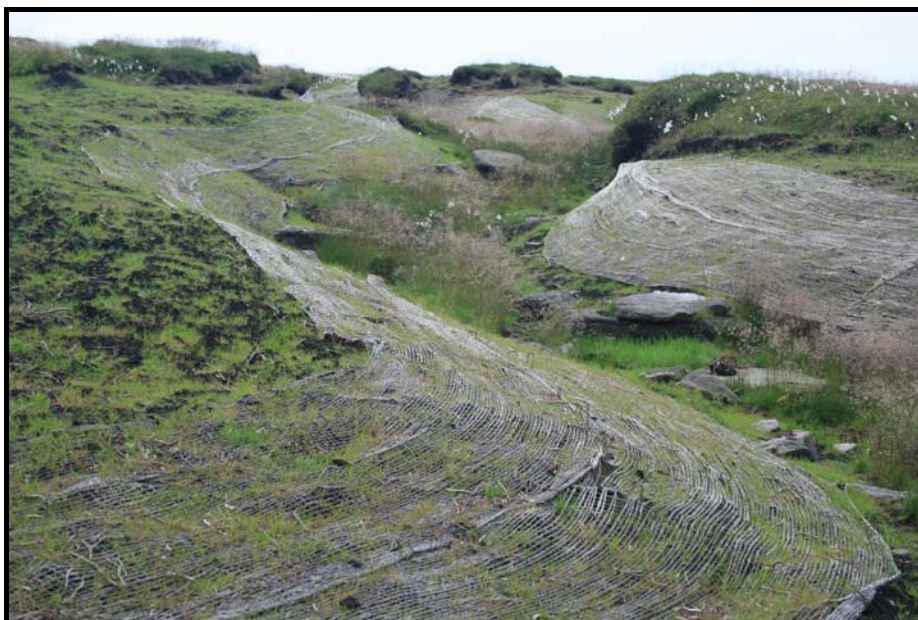
Photograph 16 *Slope Stabilisation Using Geojute Matting (note the re-vegetation following addition of lime, grass and heather seed, fertiliser and heather brash)*

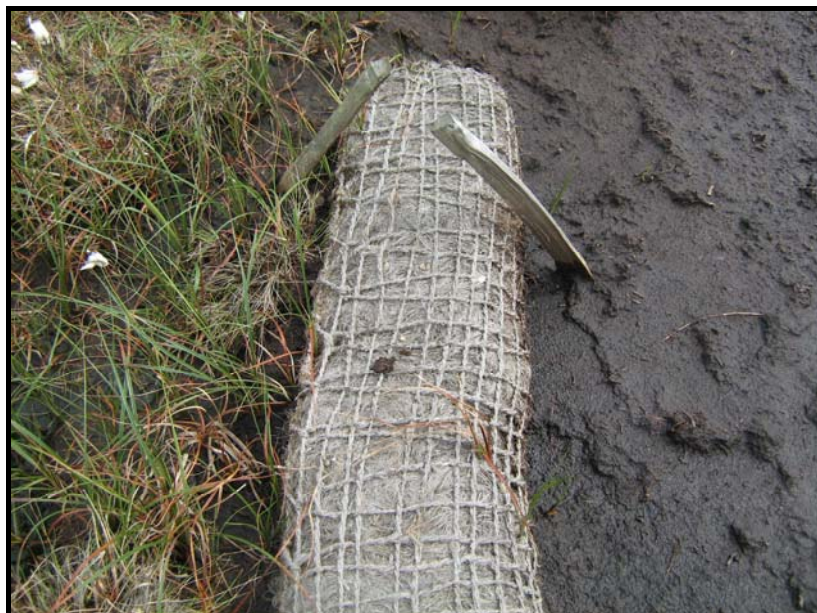
Photograph 17 Coir Roll on Ashway Gap Showing Peat Accumulating and Vegetation Colonising Behind the Coir Roll (Note the uneven surface of the exposed bare peat indicating the surface 'downstream' of the coir roll is still highly mobile and vegetation establishment is likely to be compromised)

Although vegetation re-establishment was found to be extremely slow on these areas (as anticipated) there were still promising signs of positive restoration. The removal of stock grazing appears to have had a significant effect on allowing some species, in particular those that spread by vegetative growth (common cottongrass and crowsfoot), to expand, although the cottongrass is also grazed by mountain hares which are frequently seen across the site. This expansion is rather patchy and largely dependent on there being a reasonably healthy population of that plant already present. Establishment from seed was not recorded on either of the monitoring sites, although cottongrass seedlings were observed to germinate on the bare peat (again suggesting peat soil characteristics were not inhibiting germination) but were unable to establish beyond the seedling stage. This is likely to indicate disturbance from peat soil movement, most likely related to peat re-mobilisation within each pan and possibly also freeze/thaw action over the winter period. Moss species, largely *Polytrichum*, were showing some signs of colonisation, however the carpets of *Campylopus* observed on the bare peat gullies did not appear to be developing on this area.
