UNITED UTILITIES SUSTAINABLE CATCHMENT MANAGEMENT PROGRAMME

WATER QUALITY MONITORING RESULTS JULY 2012

UNITED UTILITIES
SCAMP WATER QUALITY MONITORING
JULY 2012

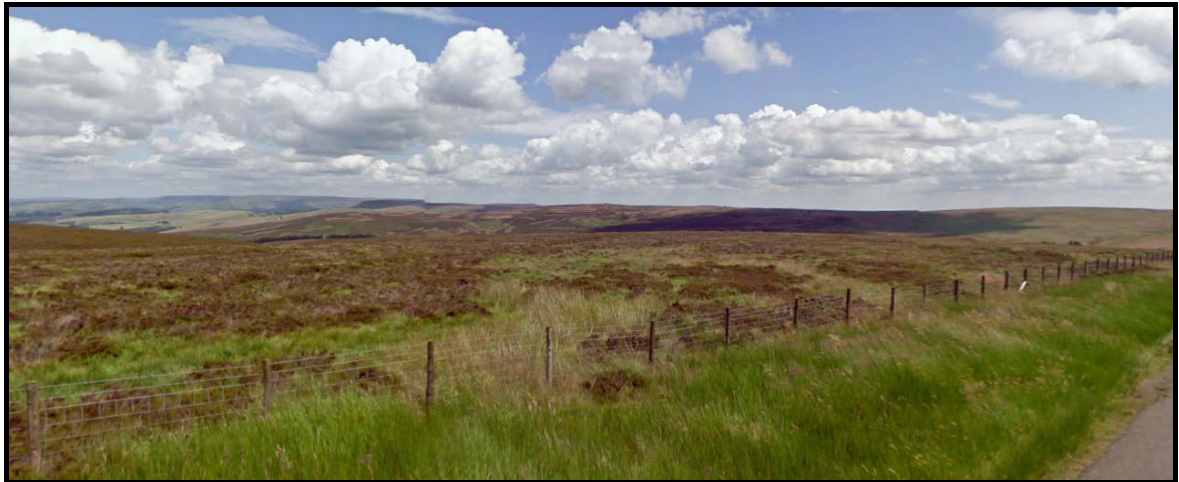
Photo 1 View Across the Goyt Valley Study Catchment

2.1 The River Goyt is a major tributary and significant headwater of the River Mersey. Rising to 525m, the sub-catchment studied within SCaMP consists of around 600ha of predominately blanket bog over deep peats (averaging 1.5m) and around 250ha of dwarf shrub heath. The vegetation is a mix of cotton grasses and dwarf shrubs typical of drier blanket bog habitat, with little *Sphagnum* cover except in the wettest areas. Figure 1 illustrates the Upper Goyt study catchment together with SCaMP monitoring plots and the location of monitoring equipment installations. Photo 1 illustrates a typical view of the Goyt study catchment.

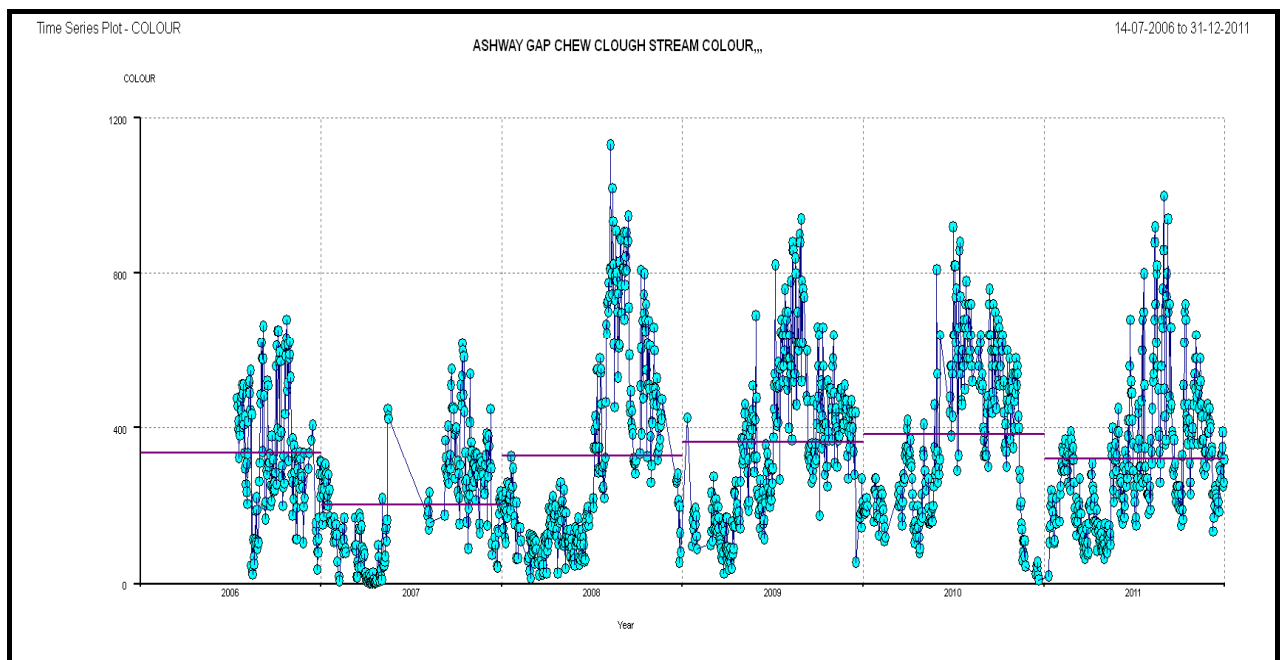
Figure 4 Chew Clough - Raw Streamflow Colour 2007-2012

- 3.11 The time series record for raw streamflow water colour in Chew Clough is illustrated in Figure 4.

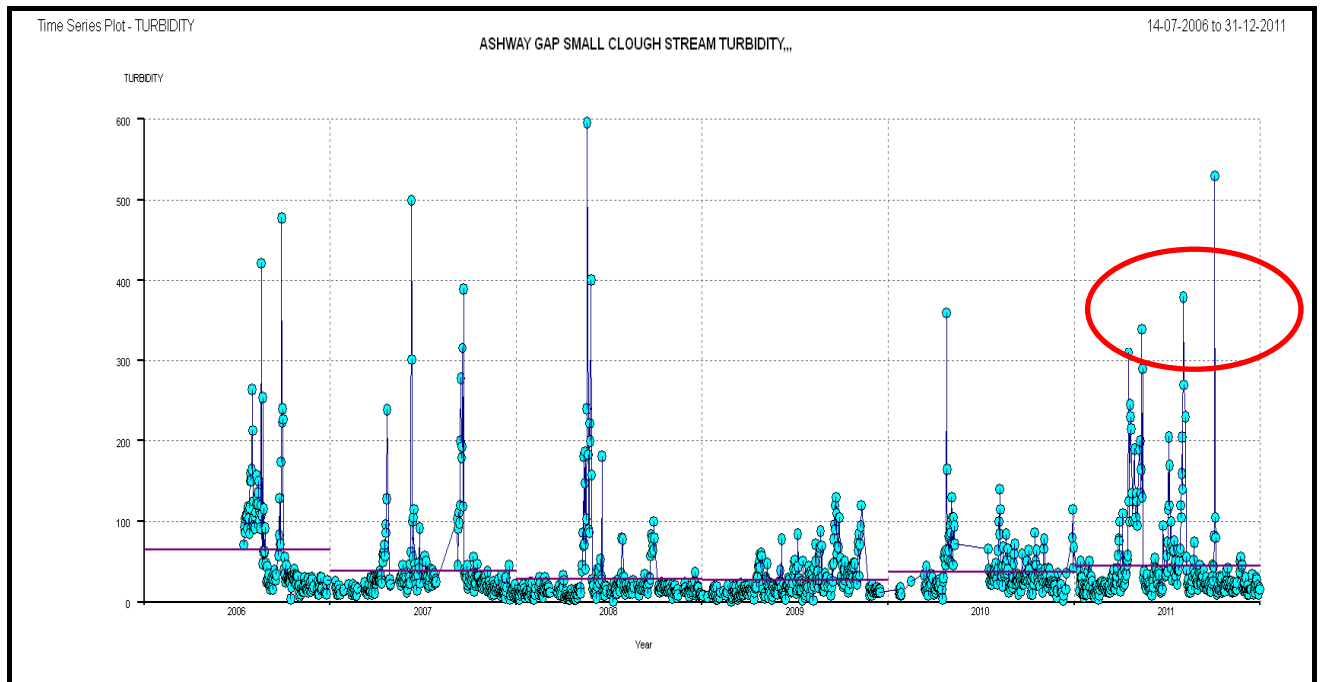
- 3.14 On Small Clough, overall trends in raw streamflow turbidity levels are static at the present time (See Figure 5). The background rate probably remains in a decreasing state, but recent presence of algae in the sample results in 2011 and 2012) has lead to false readings. Thus at

Figure 5 *Ashway Gap Small Clough - Raw Streamflow Turbidity 2008-2011*
(Red ellipse denotes turbidity spikes caused by algal blooms)

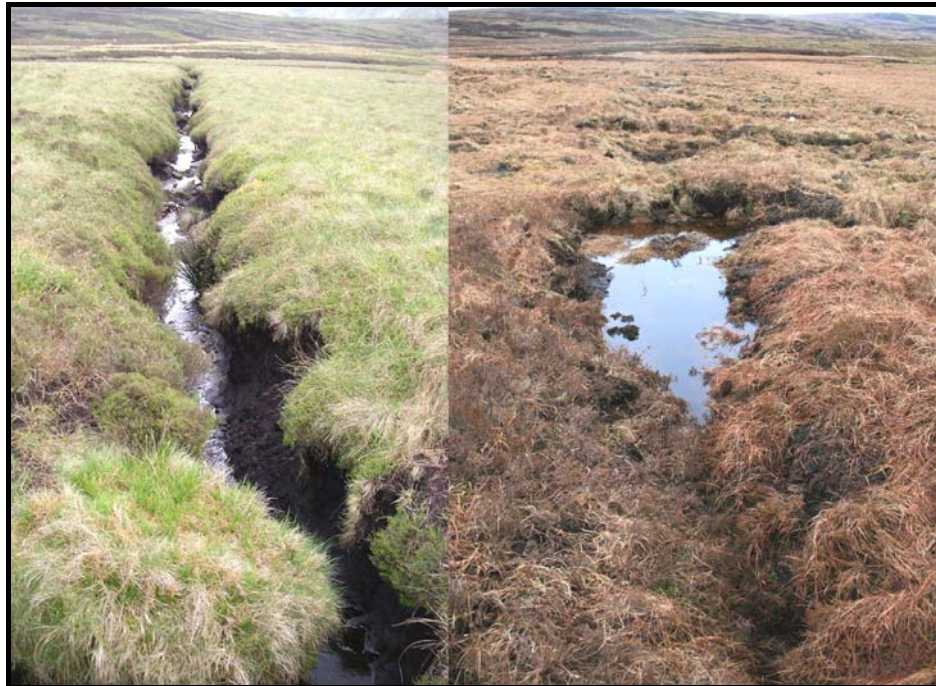
Photo 3 *Brennand Brown Syke Sub-Catchment Before (May 2007- left) and After (February 2009 - right) Major Grip Blocking Work was Completed*

4.4 Grip blocking has been carried out on Brennand and Whitendale on a large scale. The grip blocking process and its favourable consequences are illustrated in Photos 3, 4 and 5. At the same time, sheep stocking levels were reduced (Brennand) or sheep grazing was re-introduced (Whitendale). The objectives for these activities were:

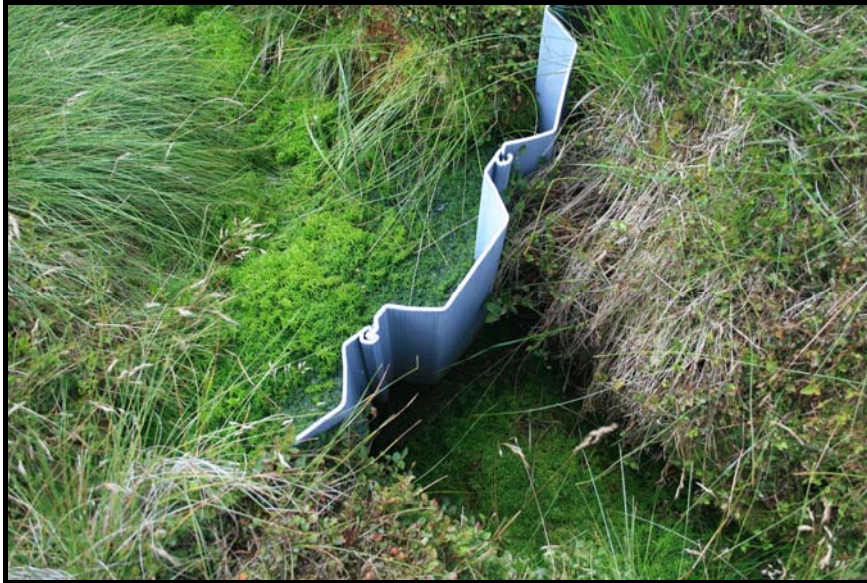
Photo 4 A Blocked Grip in the Whitendale Catchment where Vegetation Succession is Beginning to Fill in the Channel. In this Case, *Sphagnum fallax* is Building up in the Old Grip

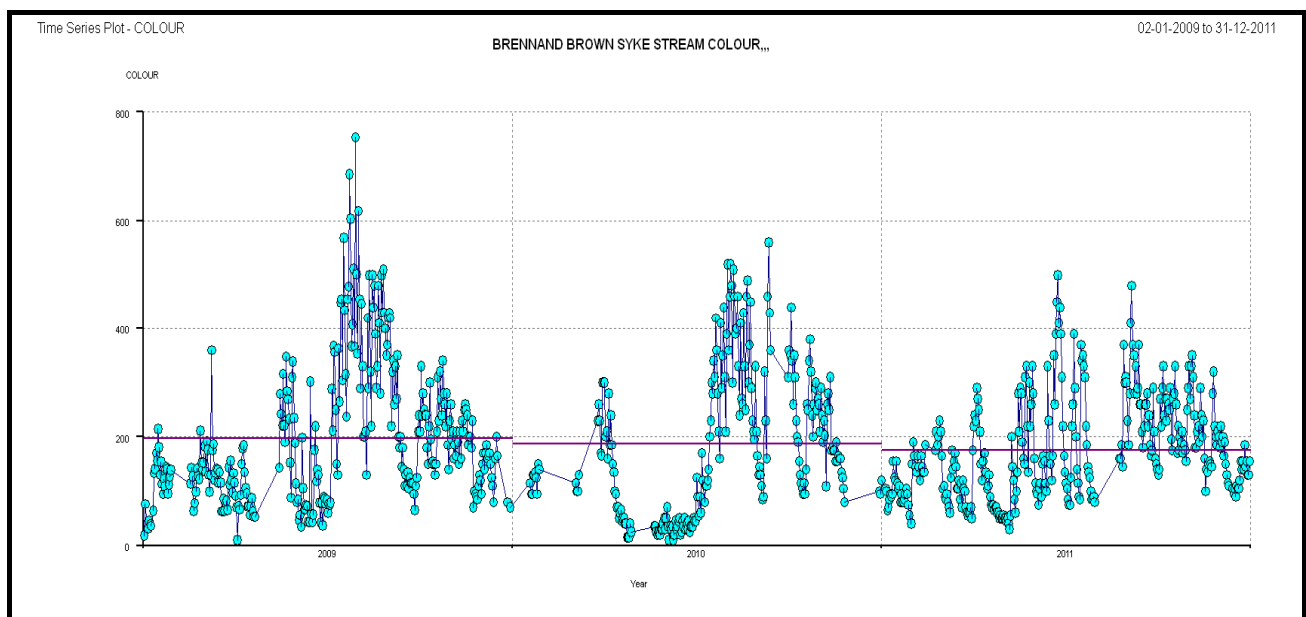
Figure 7 *Brown Syke Stream – Raw Streamflow Colour 2009-2012*

- 5.2 Results from Brown Syke Stream are more positive. The latest trend test results indicate a slight, statistically significant declining trend in colour in the post treatment (grip blocking) monitoring phase. This is supported by a review of summary statistics for the pre and post treatment phases, which show decreasing mean, median and standard deviation (variability in colour delivery) in the post treatment phase compared with the pre treatment phase. This equates to a current rate of decrease of 0.78% per annum.

- 5.3 Considering the highly degraded nature of the blanket peat across a significant area of the Brown Syke catchment, this result is perhaps the most surprising and positive. The trend is indicated in Figure 7.

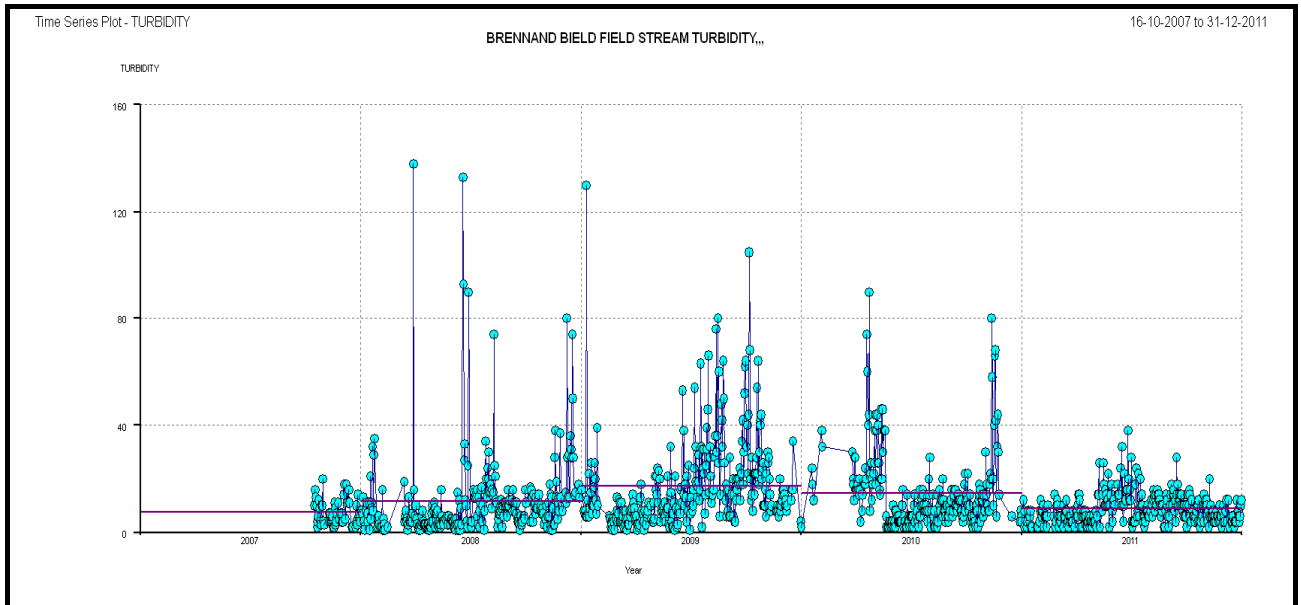
Figure 8 *Bield Field Stream – Raw Streamflow Turbidity 2007-2012*

- 5.4 In Bield Field Stream, no statistically significant directional trends in turbidity levels have been observed, although the overall trend appears to hint towards a slight decline in turbidity post grip blocking (see Figure 8). Additional statistical evidence does support this notion as the monthly mean turbidity levels are decreasing with time and, far more importantly, the variability is also decreasing, as also illustrated in Figure 8. Taken together, the results indicate a reduction in throughput of turbidity, suggesting that suspended sediment load is slightly lower and far more stable post grip blocking.
- 5.5 In Brown Syke Stream, as with Bield Field, no statistically significant directional trends in turbidity levels have been observed and the data series appears to be stationary. Here, however, there is

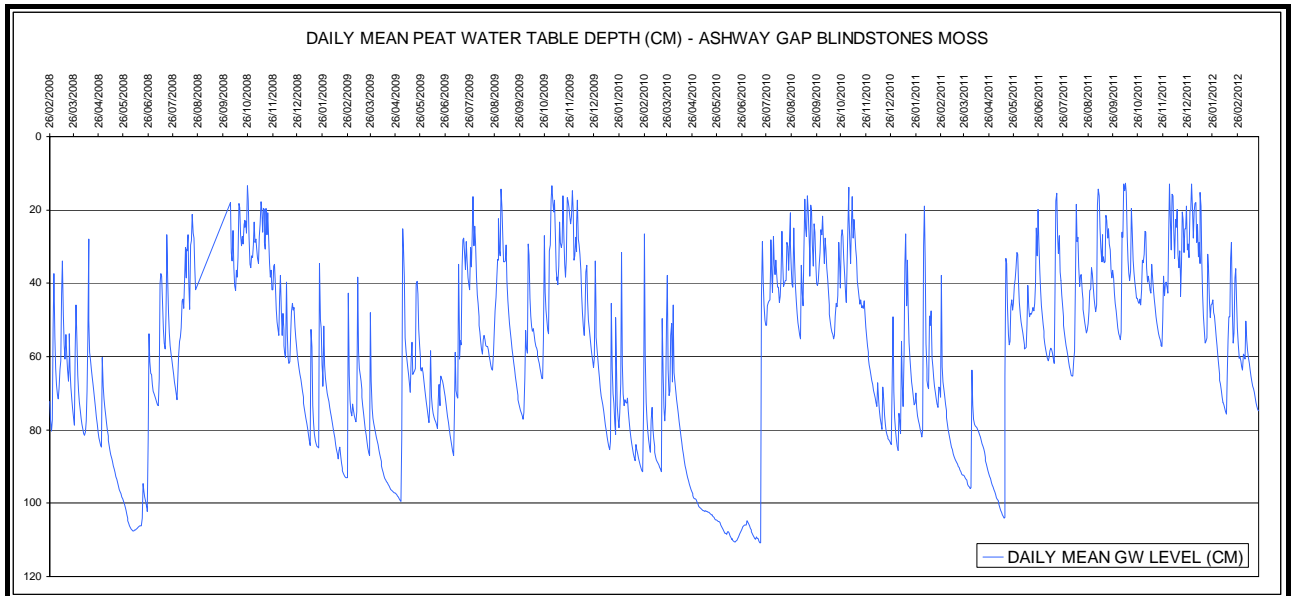
Figure 9a Mean Daily Peat Water Table Depth - Ashway Gap, Blindstones Moss Dipwell

- 6.3 The peat water table dipwell installation on Blindstones Moss, Ashway Gap is still indicating a statistically significant improving (decreasing) trend in peat water table depth over time, in the post treatment period (Figure 9a). Results indicate that background peat water table depth is decreasing, relative to the ground surface (i.e. the water table is gradually rising) in the peat body, albeit slowly and the variability in water table depth is decreasing also, suggesting a slight stabilisation in peat water table regime.

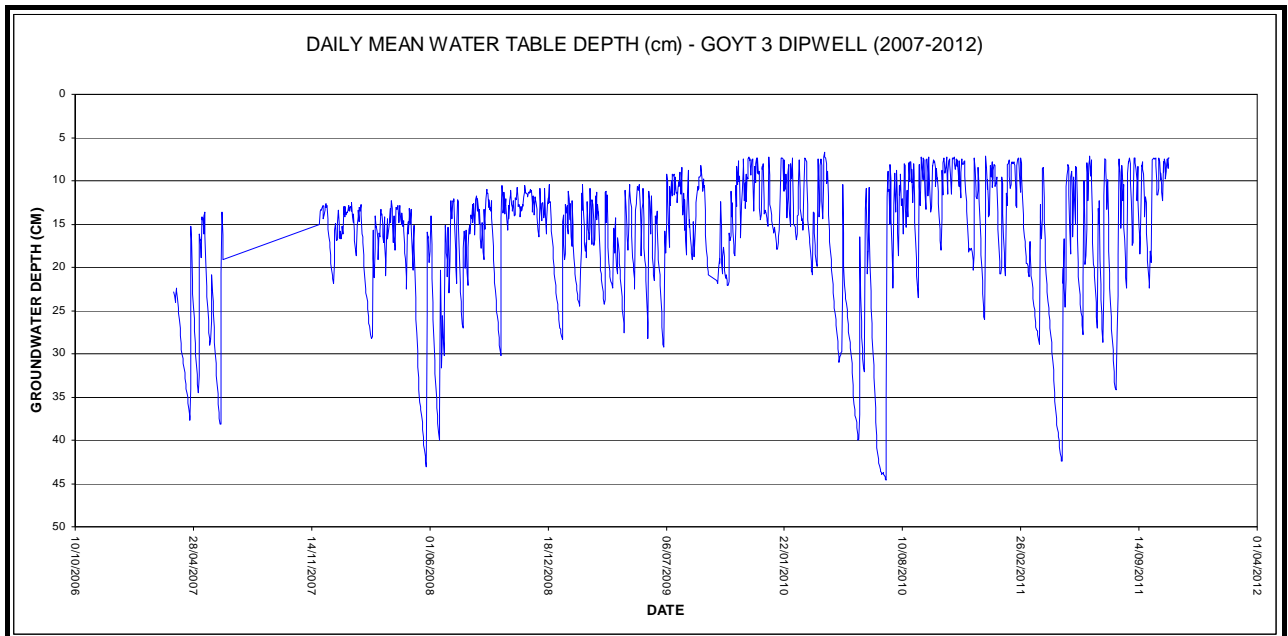
- 6.6 Visual examples of SCaMP-related peat water table level response are provided in Figure 9b and 9c. As in previous years, the Goyt 1 Raven's Low water table monitoring dipwell is consistently indicating a weak improving (decreasing) trend in peat water table depth from 2007-2012. At the Goyt 2 Derbyshire Bridge dipwell, a similar trend is observed over the same period. Finally, the trend in improving (decreasing) water table depth is again observed at the Goyt 3 Foxhole Hollow water table dipwell.
- 6.7 Again, examination of the monthly mean, median and standard deviation data allows the potential to observe and quantify changes levels and variability further. This is currently being completed.

Figure 9b Mean Daily Peat Water Table Depth – Goyt 2 Dipwell

Figure 9c Mean Daily Peat Water Table Depth – Goyt 3 Dipwell

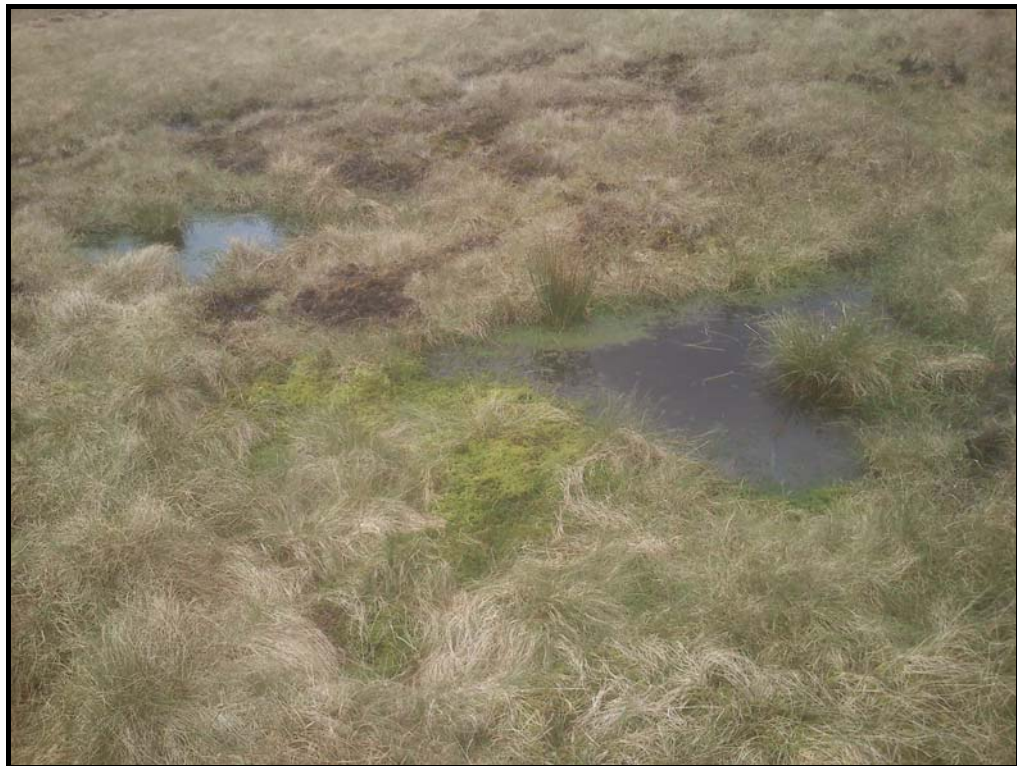
Photo 5 *Peat Water Table Recovery Leading to Vegetation Re-colonisation with Sphagnum Following Grip Blocking*

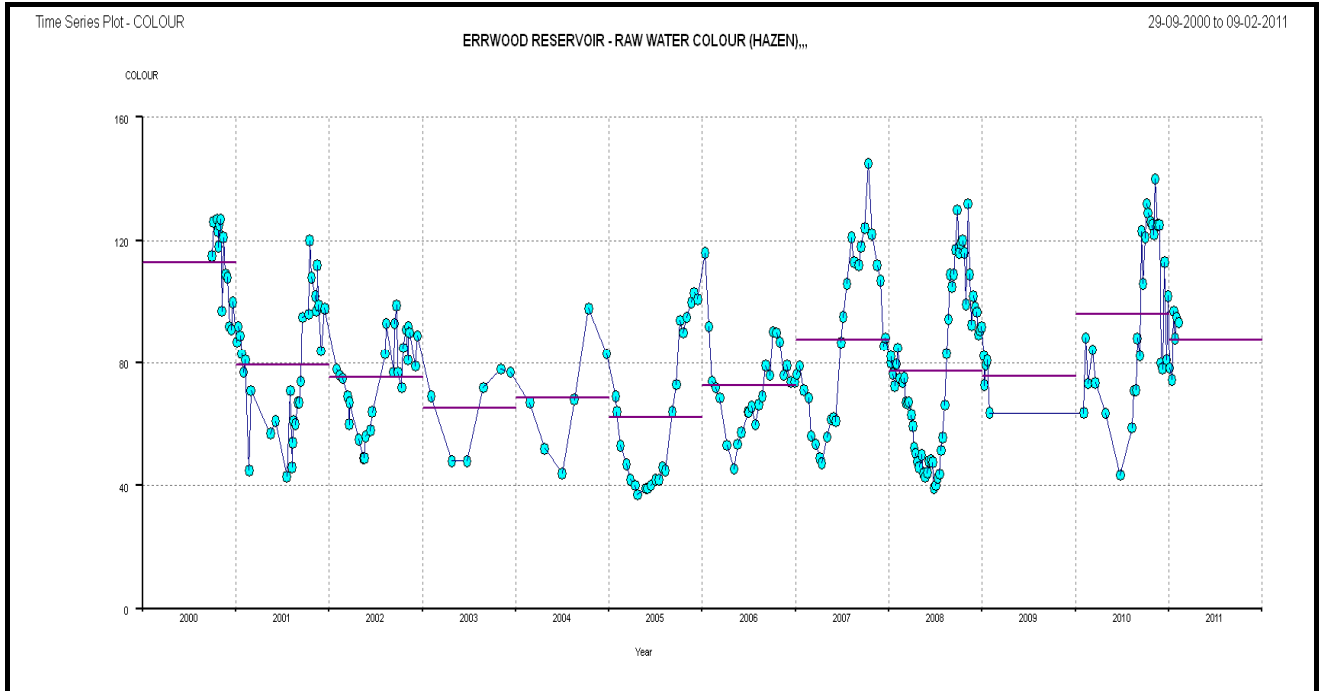
Figure 10b Raw Water Colour Time Series Plot - Errwood Reservoir, Goyt 2000--2012

- 7.3 The trend test results indicate a consistent picture of slight, but statistically significant increasing colour levels in the reservoir. When the data series are considered as a whole, including the small number of spot samples taken in the period 1990 to 2000, there is a slight, statistically significant increasing trend in raw water colour (slope 0.003, $n = 329$, $p < 0.001$).
- 7.4 This increasing trend is also observed, at the same rate (slope 0.003, $n = 319$, $p > 0.001$) when the data are confined to the period where regular monitoring began, i.e. 2000 onwards (Figure 10b).

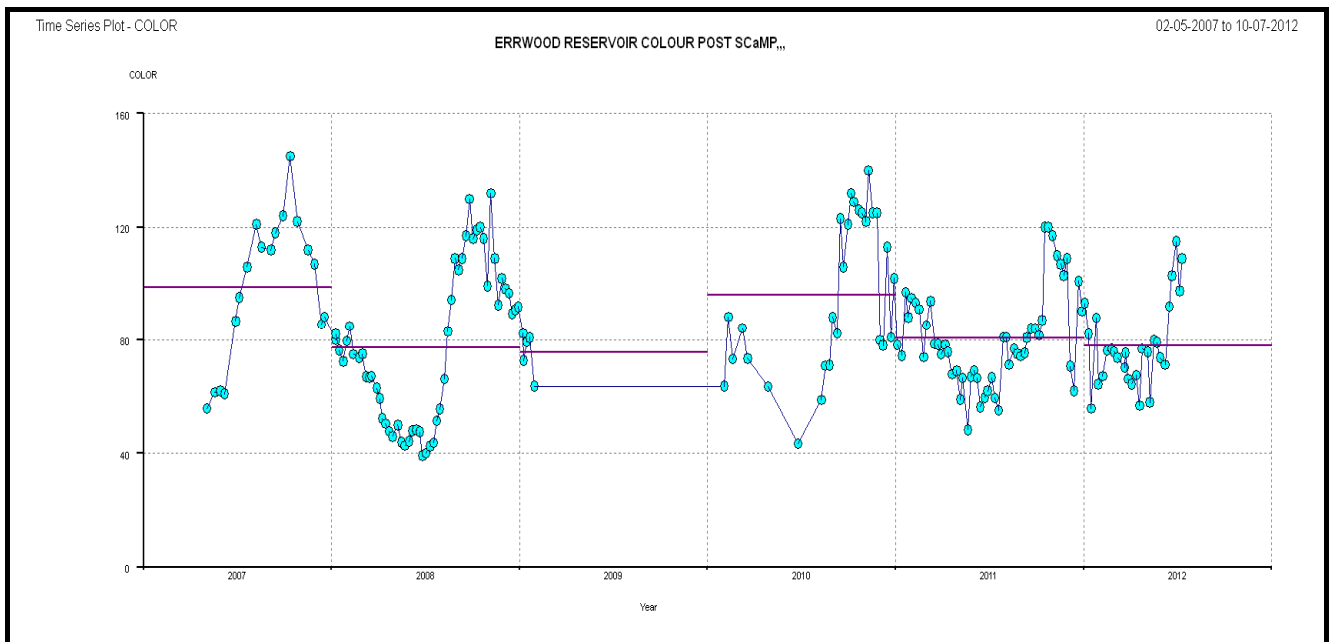
Figure 10c Raw Water Colour Time Series Plot - Errwood Reservoir, Goyt for the post SCaMP period, 2007-2012

- 7.5 However, when the dataset is further confined to the post-SCaMP land management phase, from spring of 2007 until the present, an increasing trend is observed, but at a lower rate of increase (slope 0.001, $n = 184$). These data are illustrated graphically in Figure 10c. In all cases, the trend test accounts for the strong seasonality in the data. Tentatively, this result can be interpreted that the rate of colour increase in the reservoir is slowing and that this may be direct evidence confirming that SCaMP land management treatment does have a positive effect on water quality in the reservoir.
- 7.6 Broadly speaking, the results appear to show a changing state of colour flux from one of net increase to net decrease. These results broadly support those found in the Upper Goyt stream running directly off catchment.
