Remediation of Stoke Brook and the River Derwent, Derbyshire

Gerard Hawley  
Pete Worrall  
Chris Chapman  
Penny Anderson Associates Ltd

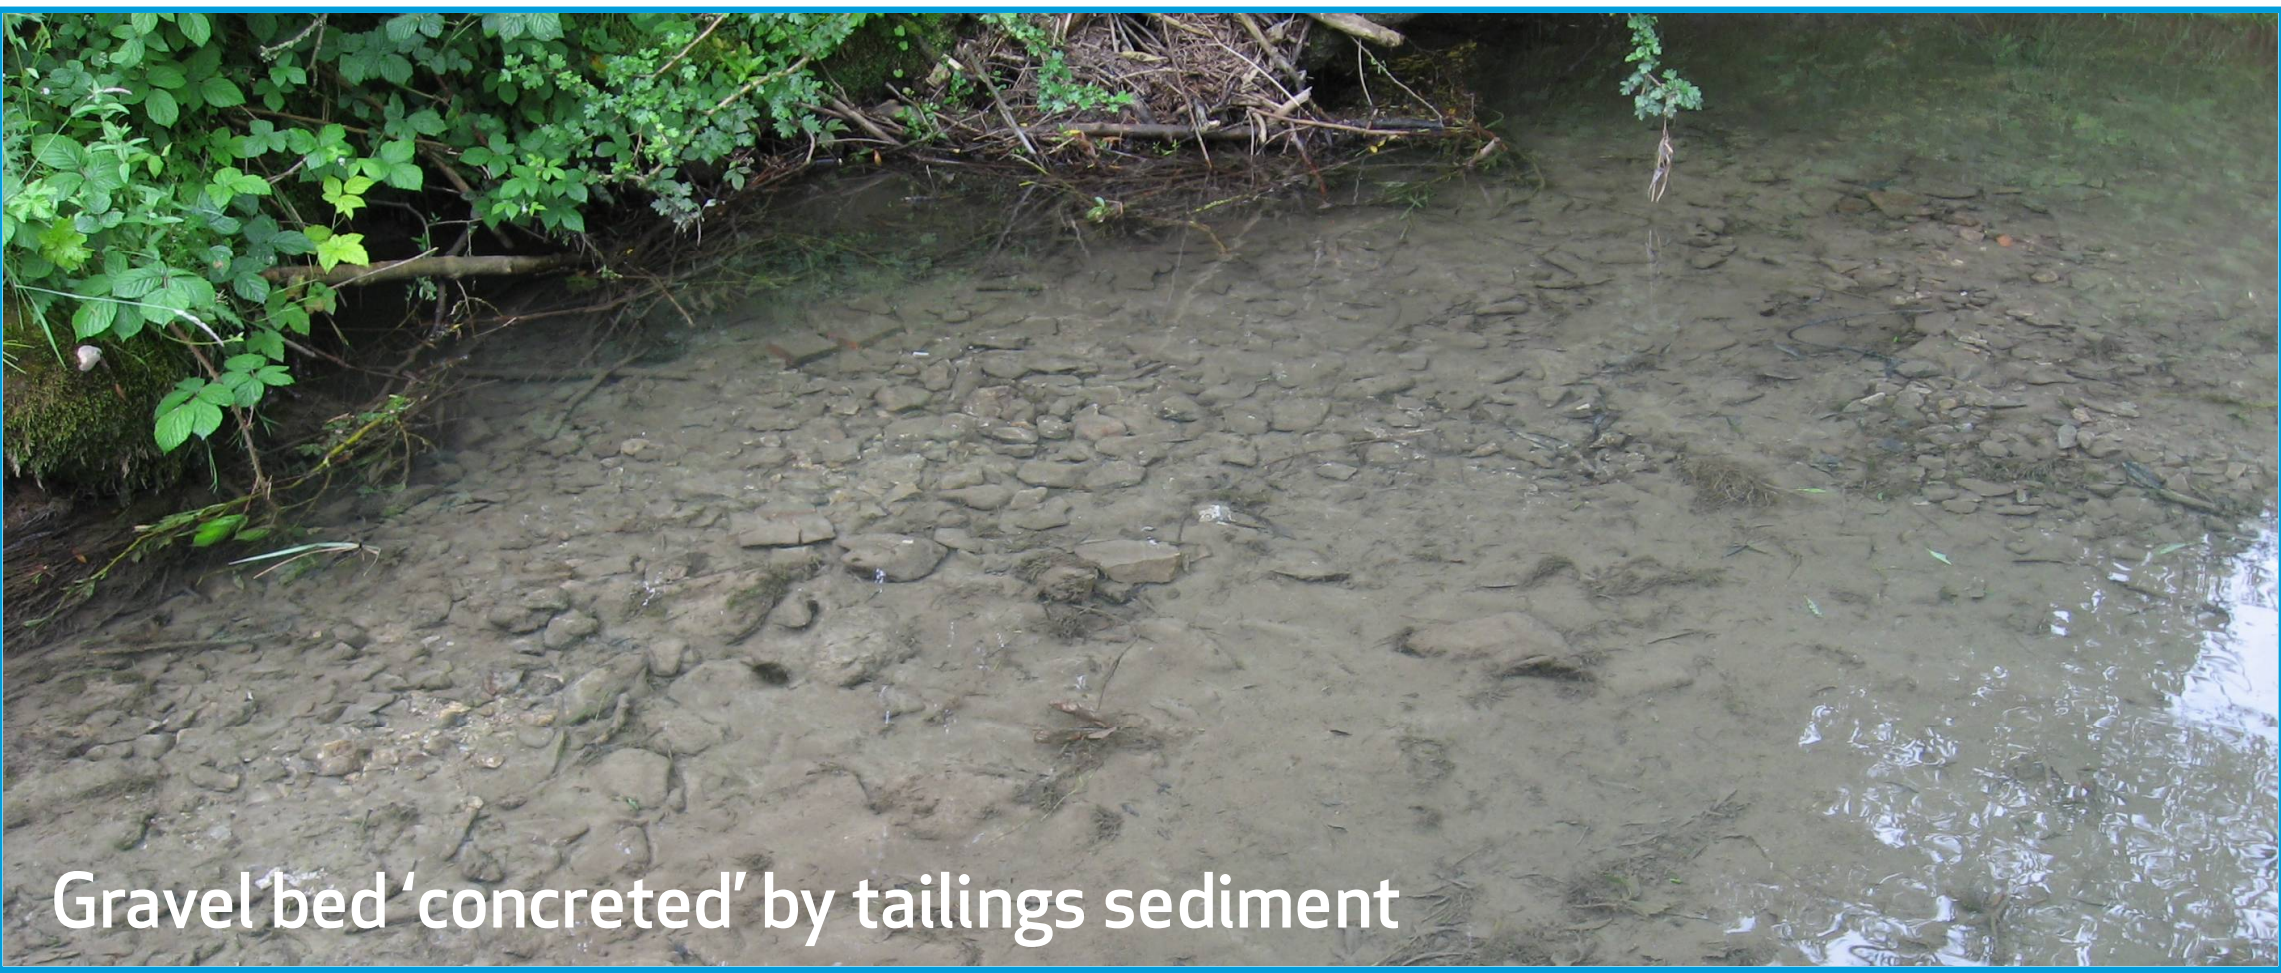
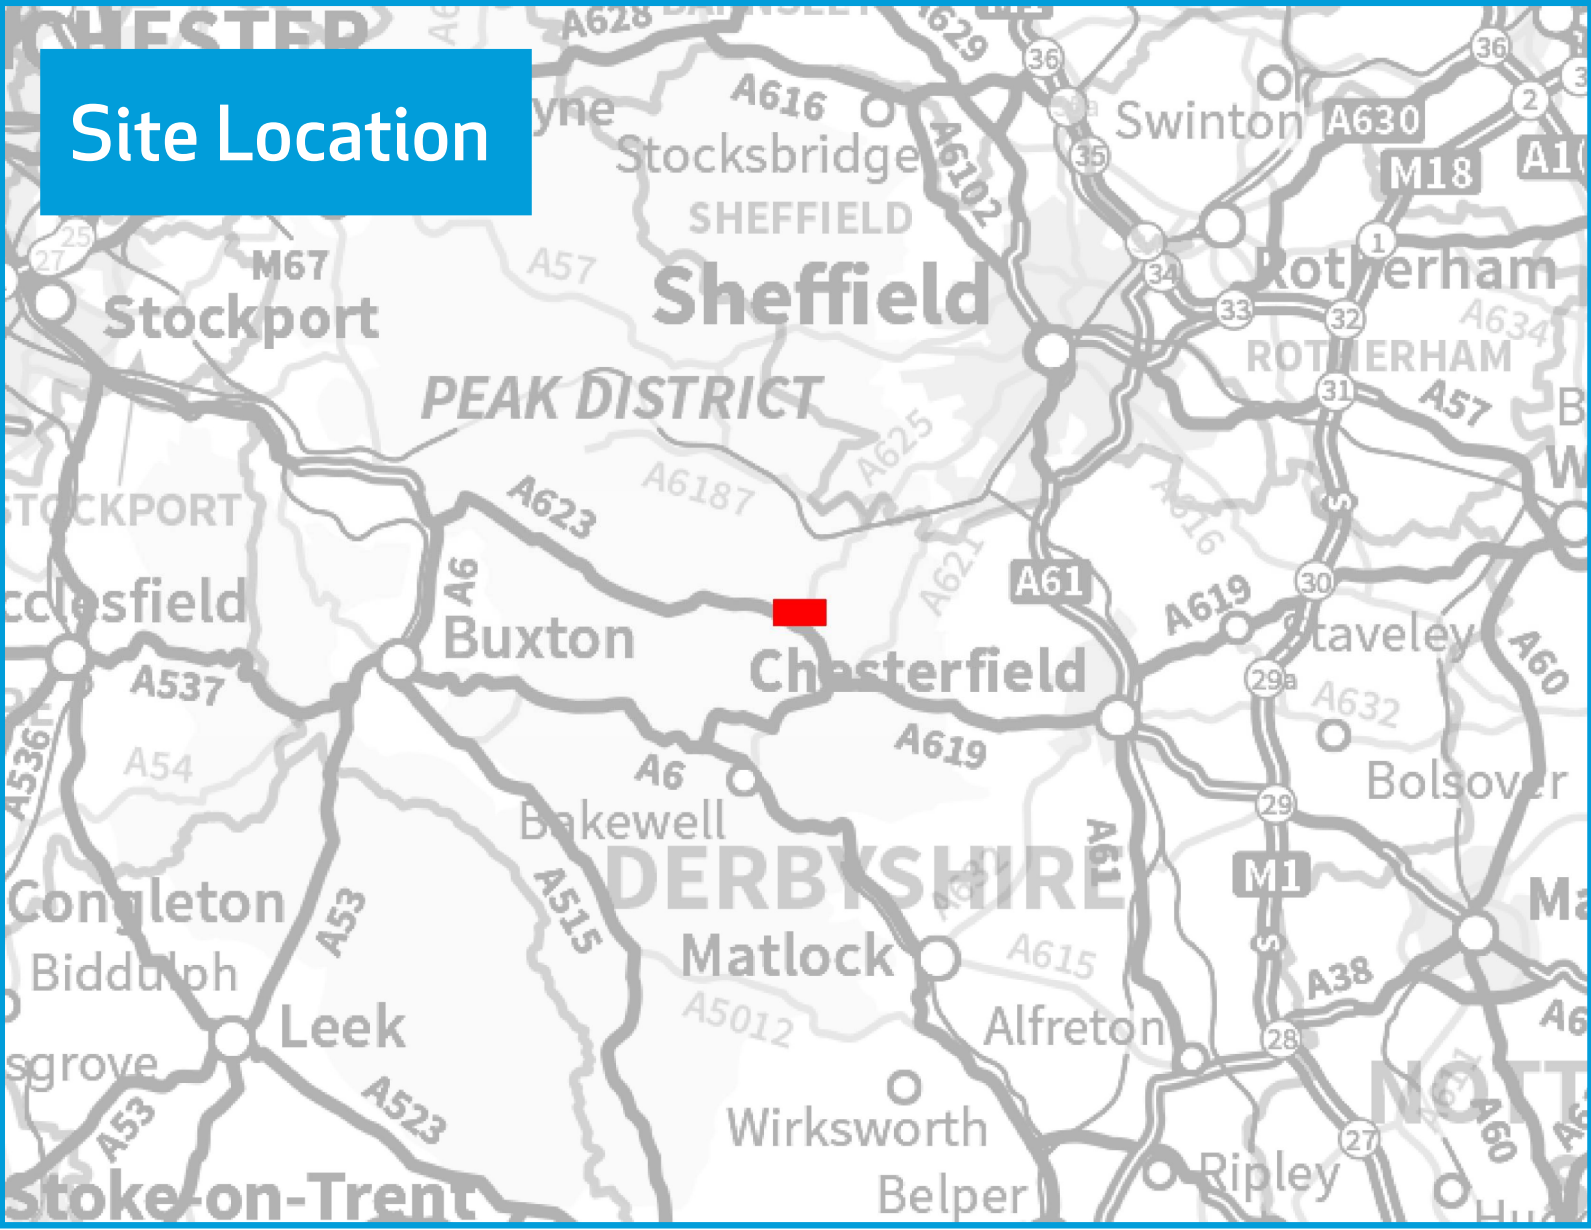
The impact of the dam failure was to smother the riverbeds and banks with a dense coating of tailings material that posed a significant risk to the integrity of the ecology of these highly diverse rivers within the Peak District National Park.

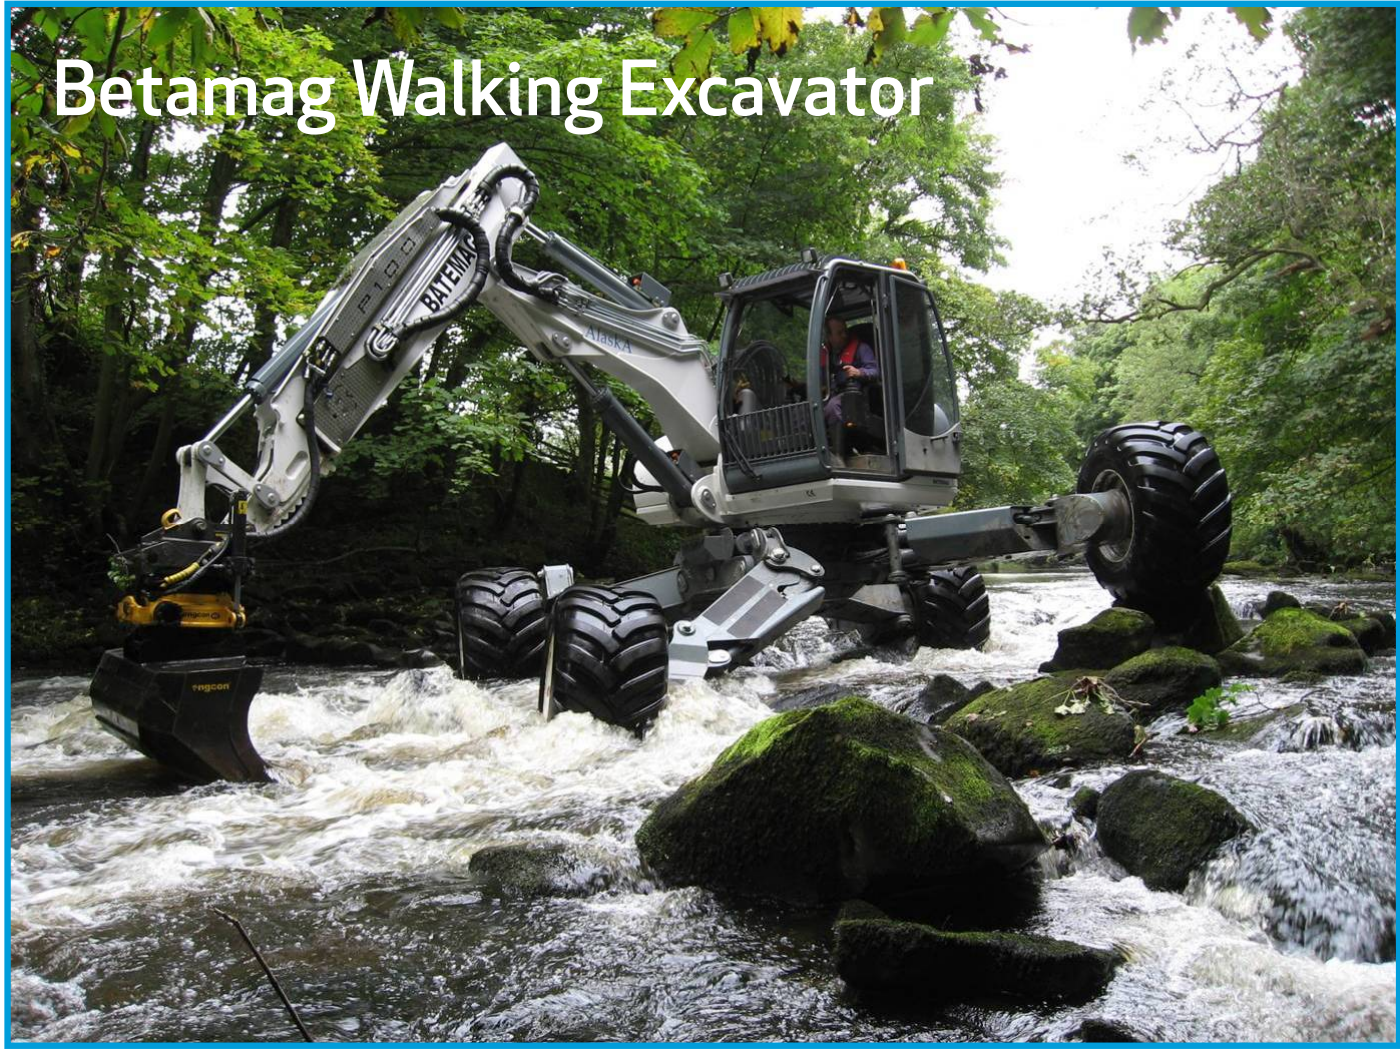
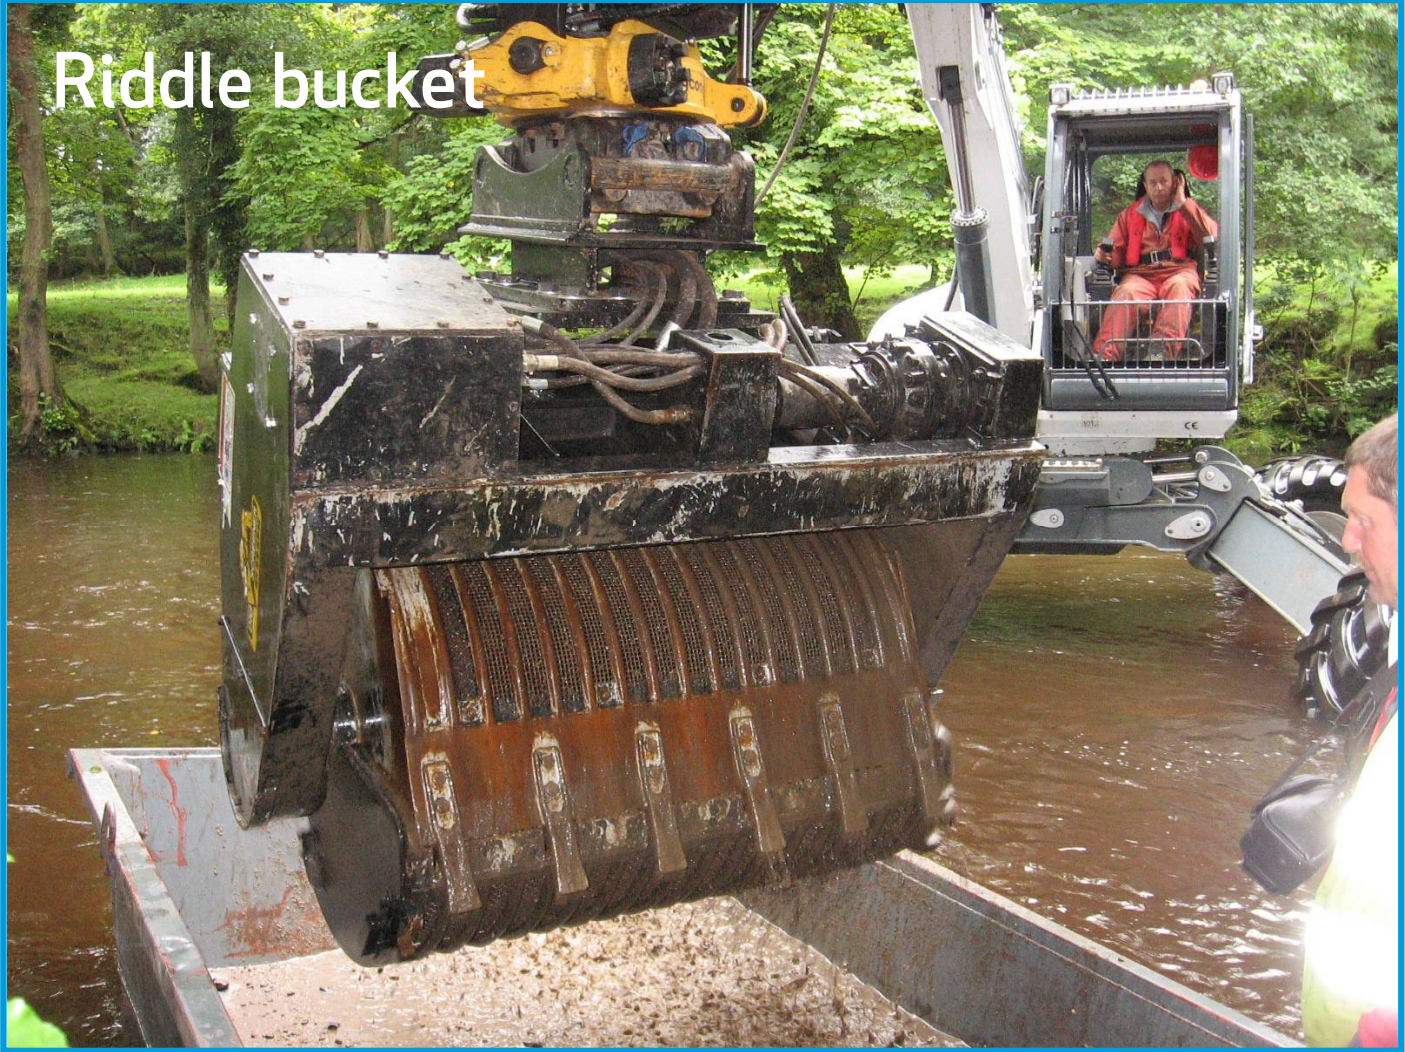
- Betamag P100 Walking Excavator, to avoid damage to the river banks
- Rotating Hydraulic Excavator Head
- Riddle Bucket, to remove fines <4mm
- Vector Vacuum Excavator, for sites inaccessible by the Betamag Excavator
- Permeable silt curtain, to prevent sediment transport downstream of the works site

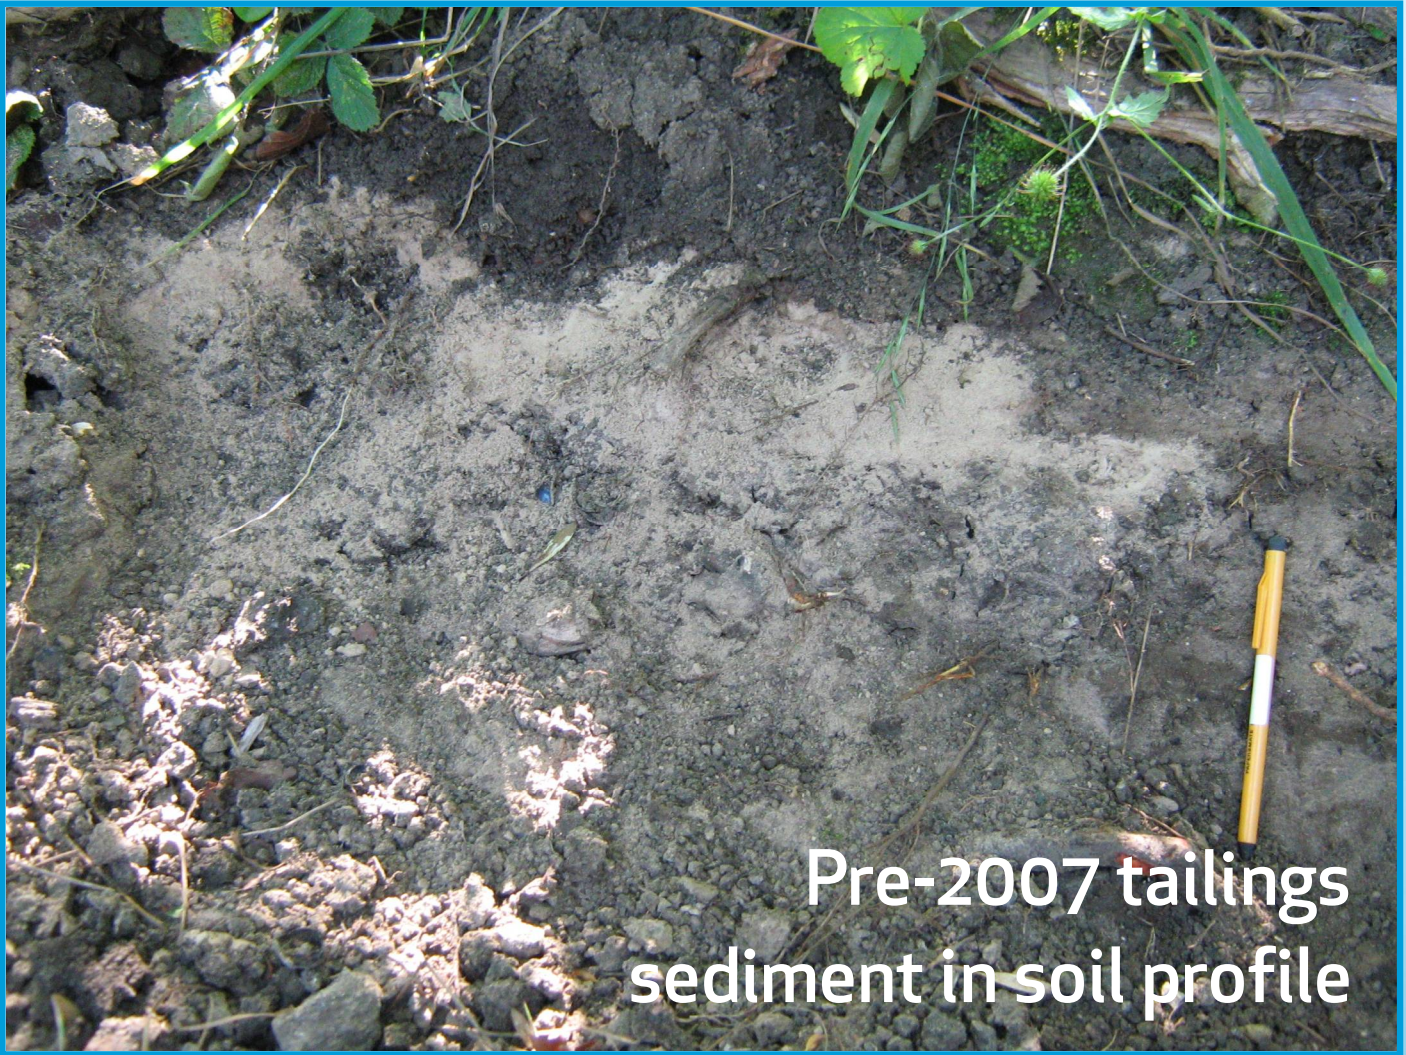
Evidence of Earlier Lagoon Failure

It became evident during surveys and further confirmed when works began, that there was a deposit of silty sand below the present day soil surface. This was often visible in the river banks that exposed the soil in profile. The texture and colour was identical to the 2007 tailings at the surface suggesting that this deposit was the result of an earlier lagoon failure.

Using an augur and Differential GPS, the depth and thickness of the pre-2007 sediment was measured, and an estimated 2,857m<sup>3</sup> was found to be deposited within the Stoke Brook floodplain. However, it has not been possible to determine when this occurred but it must be since the Cavendish Mill opened in 1959.
